Pavement Condition Report

Waseca Municipal Airport (ACQ)

December 2016

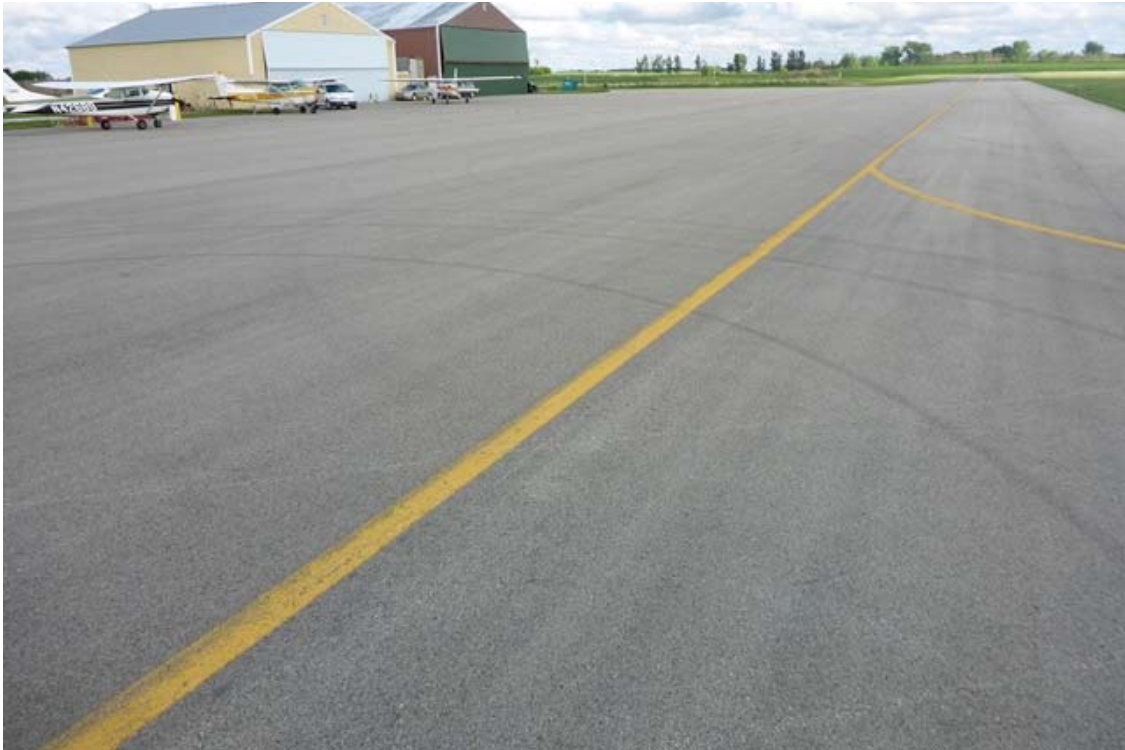
ACQ APA 001 (PCI = 98)

Conditions: PCI: 98

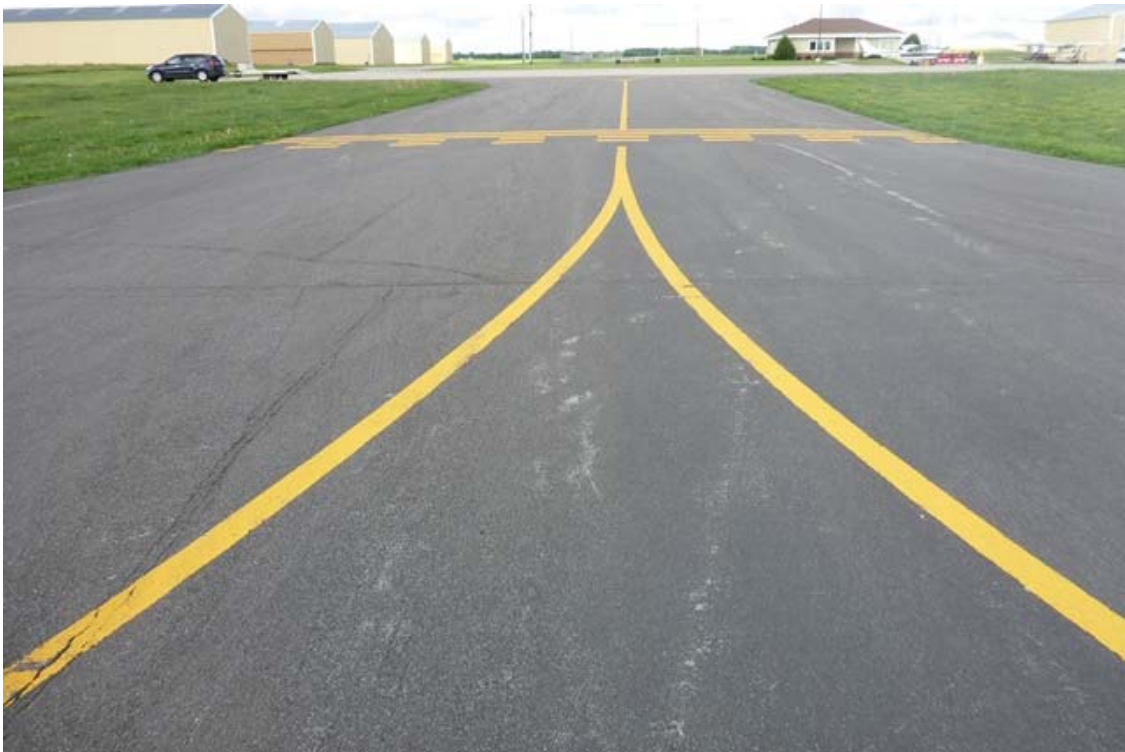
ACQ CTA 001 (PCI = 82)

Network:	ACQ	Name:	WASECA						
Branch:	CTA	Name:	CONNECTING TAXIWAY A	Use:	TAXIWAY	Area:	14,000 SqFt		
Section:	001	of 1	From:	100	To:	101	Last Const.:	11/16/1999	
Surface:	AC	Family:	MN2013 Asphalt Taxiways	Zone:	S	Category:	3	Rank:	P
Area:	14,000 SqFt	Length:	225 Ft	Width:	40 Ft				
Slabs:		Slab Length:	Ft	Slab Width:	Ft	Joint Length:	Ft		
Shoulder:		Street Type:		Grade:	0	Lanes:	0		
Section Comments:									
Last Insp. Date:	5/27/2016	TotalSamples:	3	Surveyed:	1				
Conditions:	PCI: 82								
Inspection Comments:									
Sample Number:	101	Type:	R	Area:	4000.00 SqFt	PCI:	82		
Sample Comments:									
48	L & T CR	L	169.00 Ft						
50	PATCHING	L	60.00 SqFt

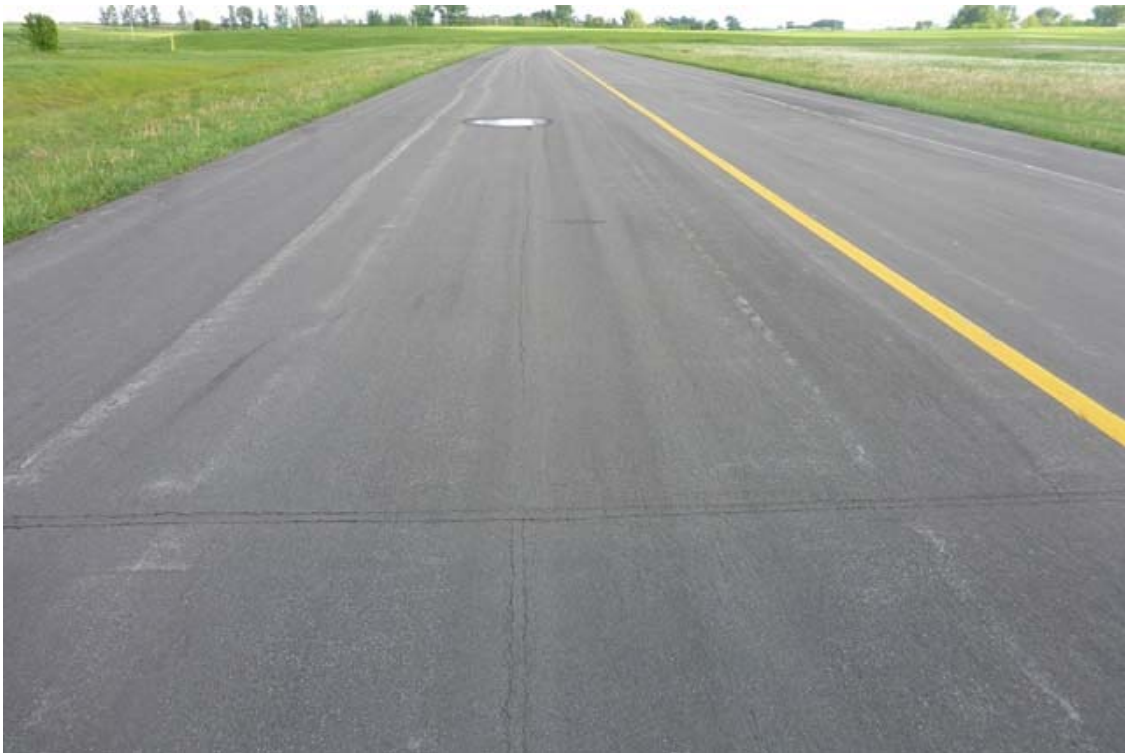
ACQ PPTA 001 (PCI = 84)

Conditions: PCI: 84

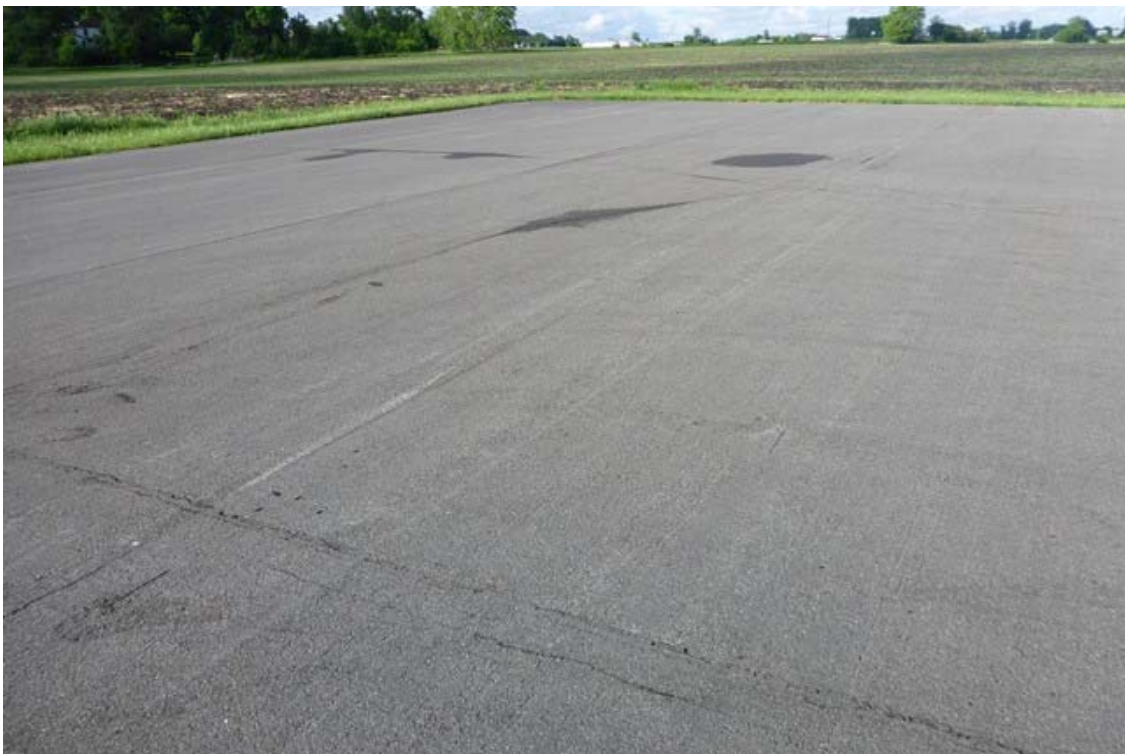
ACQ RTA 001 (PCI = 81)

Network:	ACQ	Name:	WASECA						
Branch:	RTA	Name:	RUNWAY TURNAROUND	Use:	TAXIWAY	Area:	12,225 SqFt		
Section:	001	of 1	From:	168	To:	169	Last Const.:	11/16/1999	
Surface:	AC	Family:	MN2013 Asphalt Taxiways	Zone:	S	Category:	3	Rank:	S
Area:	12,225 SqFt	Length:	130 Ft	Width:	90 Ft				
Slabs:		Slab Length:	Ft	Slab Width:	Ft	Joint Length:	Ft		
Shoulder:		Street Type:		Grade:	0	Lanes:	0		
Section Comments:									
Last Insp. Date:	5/27/2016	TotalSamples:	2	Surveyed:	1				
Conditions:	PCI: 81								
Inspection Comments:									
Sample Number:	267	Type:	R	Area:	7150.00 SqFt	PCI:	81		
Sample Comments:	Slurry Seal Good								
50	PATCHING	L	30.00	SqFt					
48	L & T CR	L	427.00	Ft

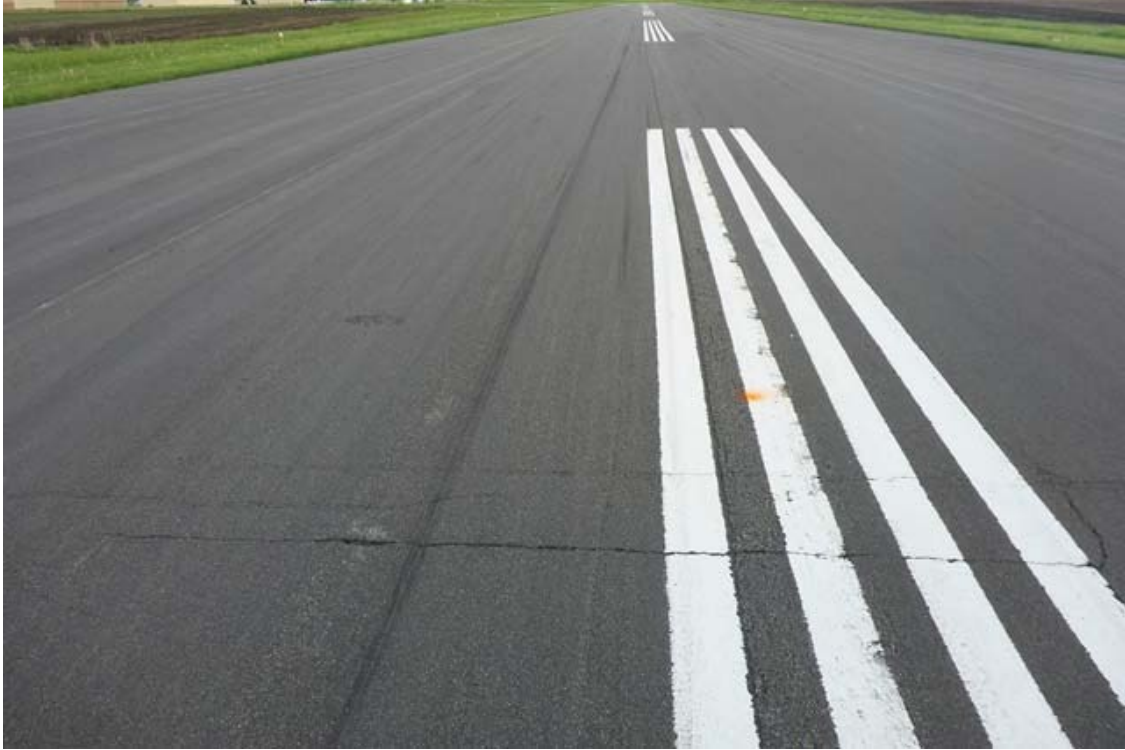
ACQ RY1533 001 (PCI = 79)

Network:	ACQ	Name:	WASECA						
Branch:	RY1533	Name:	RUNWAY 15-33	Use:	RUNWAY	Area:	254,850 SqFt		
Section:	001	of 1	From:	100	To:	167	Last Const.:	11/16/1999	
Surface:	AC	Family:	MN2013 Asphalt Runways	Zone:	S	Category:	3	Rank:	P
Area:	254,850 SqFt	Length:	3,398 Ft	Width:	75 Ft				
Slabs:		Slab Length:	Ft	Slab Width:	Ft	Joint Length:	Ft		
Shoulder:		Street Type:		Grade:	0	Lanes:	0		
Section Comments:									
Last Insp. Date:	5/27/2016	TotalSamples:	68	Surveyed:	7				
Conditions:	PCI: 79								
Inspection Comments: Slurry Seal 2015									
Sample Number:	104	Type:	R	Area:	3750.00 SqFt	PCI:	81		
Sample Comments:									
48	L & T CR	L	264.00	Ft					
Sample Number:	114	Type:	R	Area:	3750.00 SqFt	PCI:	77		
Sample Comments:									
48	L & T CR	L	277.00	Ft					
50	PATCHING	L	38.00	SqFt					
Sample Number:	124	Type:	R	Area:	3750.00 SqFt	PCI:	75		
Sample Comments:									
48	L & T CR	L	353.00	Ft					
50	PATCHING	L	10.00	SqFt

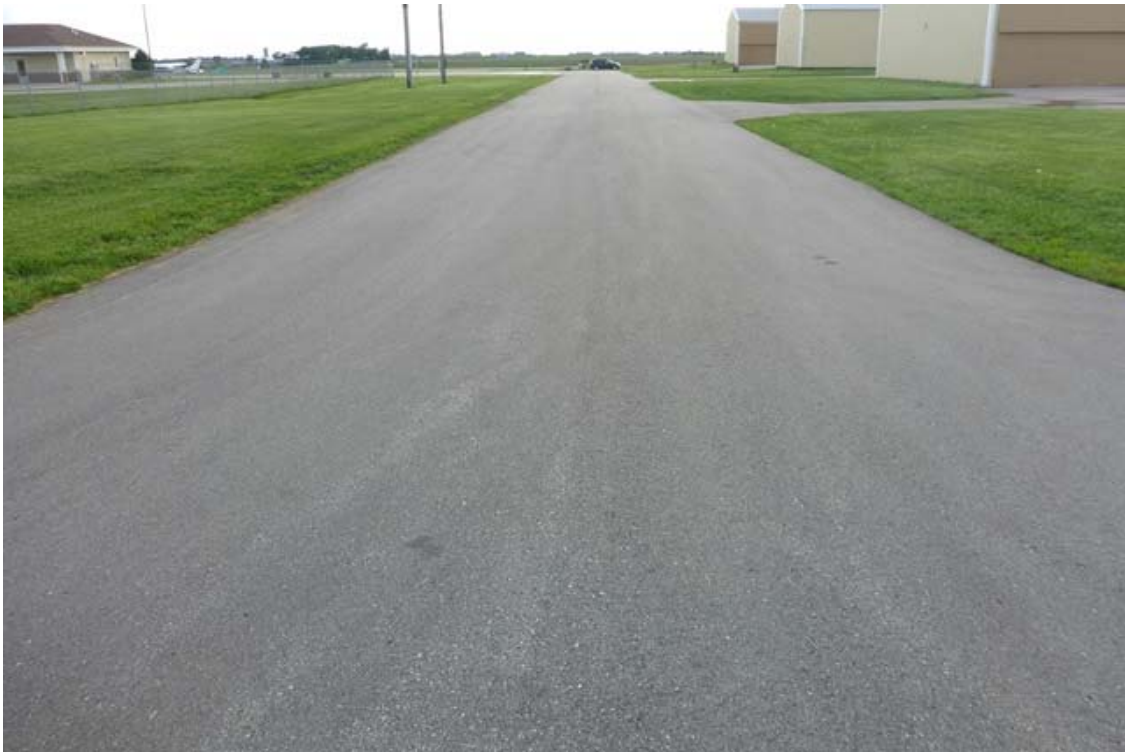
ACQ TLA 001 (PCI = 95)

Network:	ACQ	Name:	WASECA						
Branch:	TLA	Name:	TAXILANE A	Use:	TAXILANE	Area:	30,200 SqFt		
Section:	001	of 2	From:	407	To:	408	Last Const.: 10/11/2013		
Surface:	AAC	Family:	MN2013 Asphalt Taxilanes	Zone:	S	Category:	3	Rank:	T
Area:	9,300 SqFt	Length:	300 Ft	Width:	20 Ft				
Slabs:	Slab Length:	Ft	Slab Width:	Ft	Joint Length:	Ft			
Shoulder:	Street Type:		Grade:	0	Lanes:	0			
Section Comments:	Estimated LCD								
Last Insp. Date:	5/27/2016	TotalSamples:	3	Surveyed:	1				
Conditions:	PCI: 95								
Inspection Comments:									
Sample Number:	404	Type:	R	Area:	3000.00 SqFt	PCI:	95		
Sample Comments:									
48	L & T CR	L	37.00	Ft

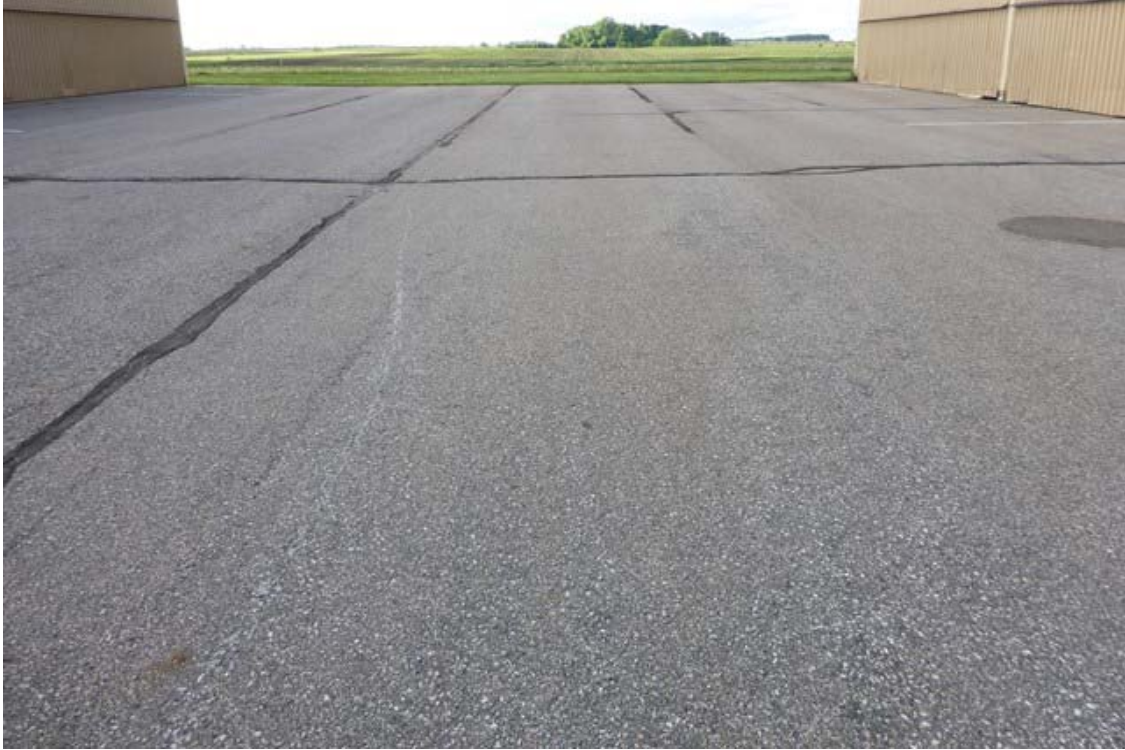
ACQ TLA 002 (PCI = 73)

Conditions: PCI: 73

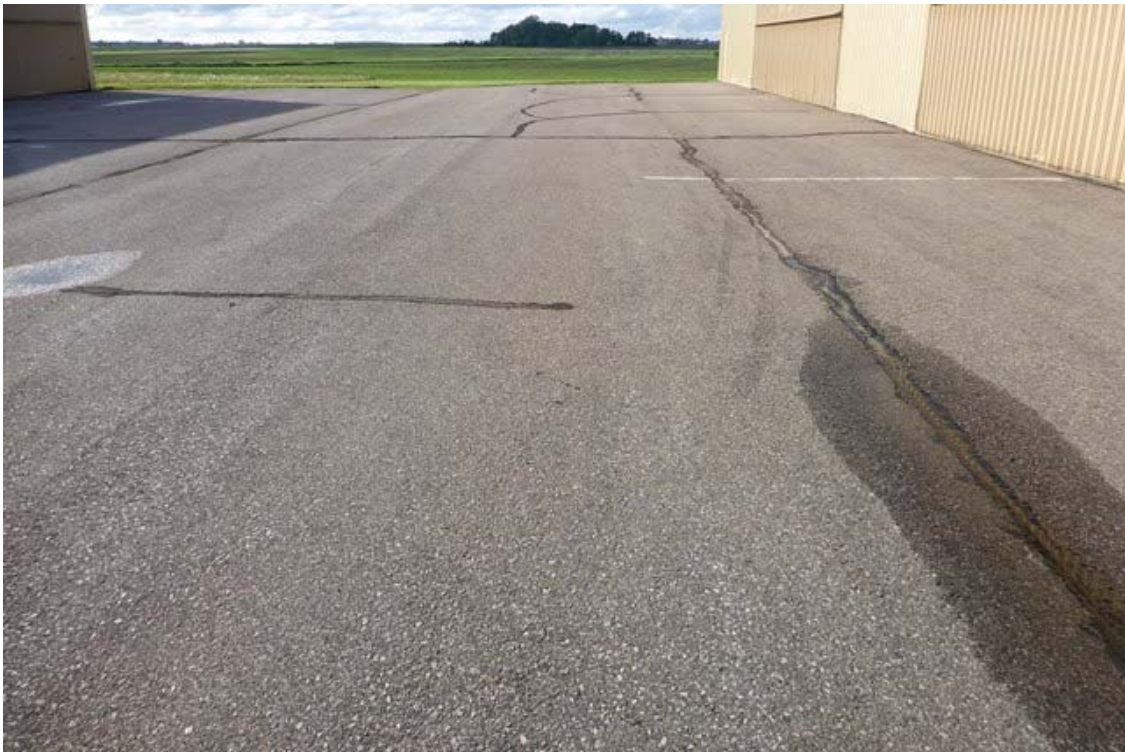
ACQ TLB 001 (PCI = 62)

Conditions: PCI: 62

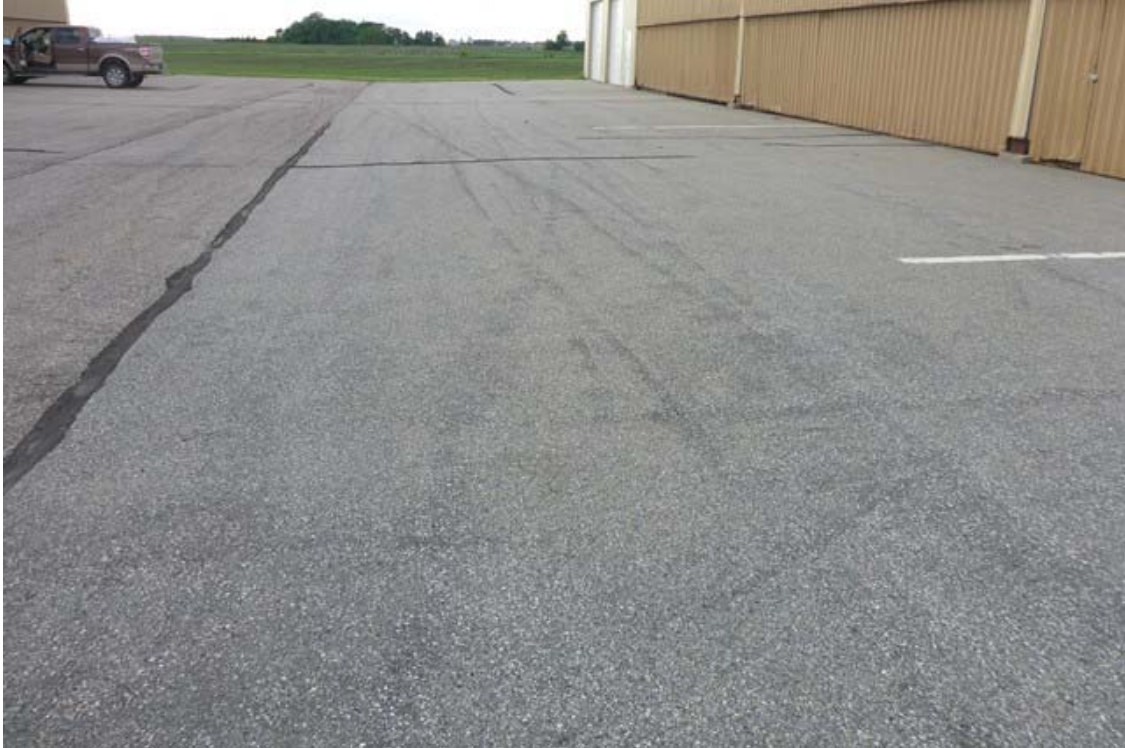
ACQ TLB 002 (PCI = 93)

Network:	ACQ	Name:	WASECA						
Branch:	TLB	Name:	TAXILANE B	Use:	TAXILANE	Area:	17,480 SqFt		
Section:	002	of 2	From:	510	To:	511	Last Const.:	6/30/2008	
Surface:	AAC	Family:	MN2013 Asphalt Taxilanes	Zone:	S	Category:	3	Rank:	T
Area:	5,550 SqFt	Length:	170 Ft	Width:	30 Ft				
Slabs:	Slab Length:	Ft	Slab Width:	Ft	Joint Length:	Ft			
Shoulder:	Street Type:	Grade:	0	Lanes:	0				
Section Comments:	Estimated LCD								
Last Insp. Date:	5/27/2016	TotalSamples:	2	Surveyed:	1				
Conditions:	PCI: 93								
Inspection Comments:									
Sample Number:	906	Type:	R	Area:	3000.00 SqFt	PCI:	93		
Sample Comments:									
48	L & T CR	L	61.00	Ft

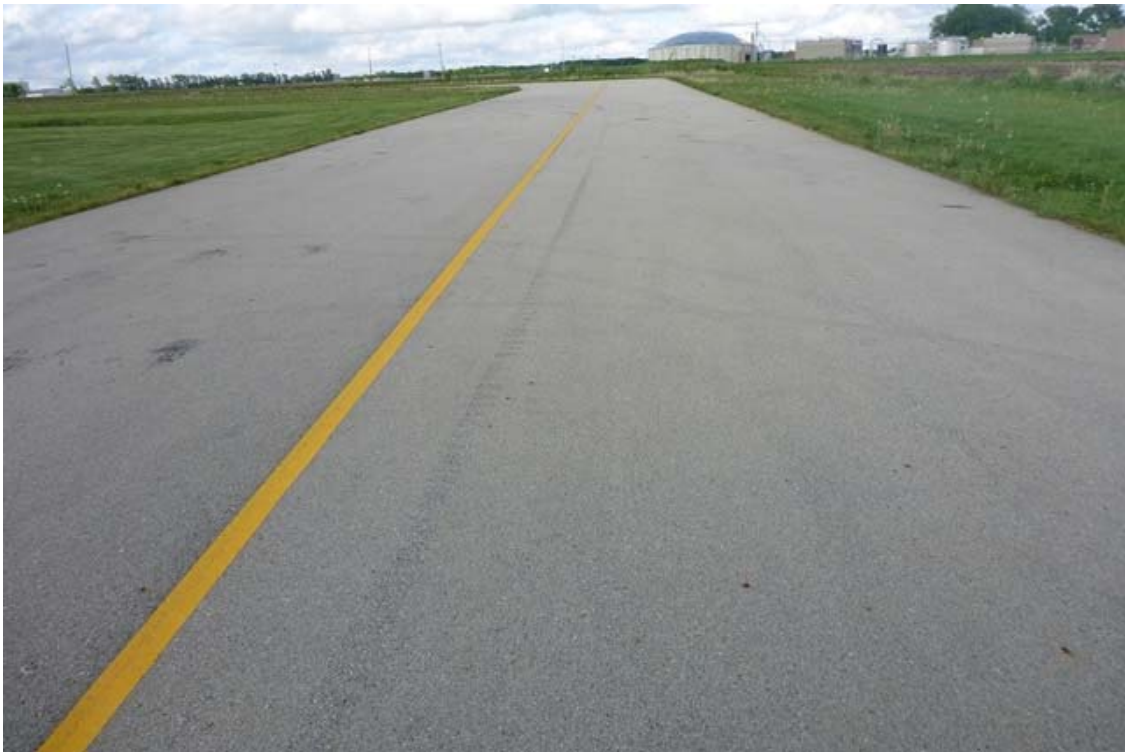
ACQ TLC 001 (PCI = 98)

Network:	ACQ	Name:	WASECA				
Branch:	TLC	Name:	TAXILANE C	Use:	TAXILANE	Area:	21,700 SqFt
Section:	001	of 1	From:	-	To:	-	Last Const.: 7/1/2012
Surface:	AC	Family:	MN2013 Asphalt Taxilanes	Zone:		Category:	Rank: T
Area:	21,700 SqFt	Length:	620 Ft	Width:	35 Ft		
Slabs:		Slab Length:	Ft	Slab Width:	Ft	Joint Length:	Ft
Shoulder:		Street Type:		Grade:	0	Lanes:	0
Section Comments:							
Last Insp. Date:	5/27/2016	TotalSamples:	6	Surveyed:	2		
Conditions:	PCI: 98						
Inspection Comments:							
Sample Number:	101	Type:	R	Area:	3500.00 SqFt	PCI:	96
Sample Comments:							
48	L & T CR	L	18.00 Ft				
Sample Number:	104	Type:	R	Area:	3500.00 SqFt	PCI:	100
Sample Comments:							
<No Distress>
