Pavement Condition Report

Wadena Municipal Airport (ADC)

December 2017

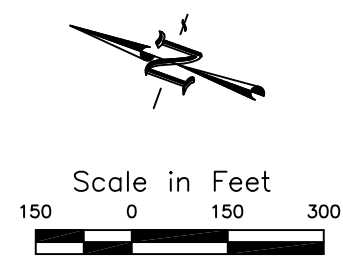
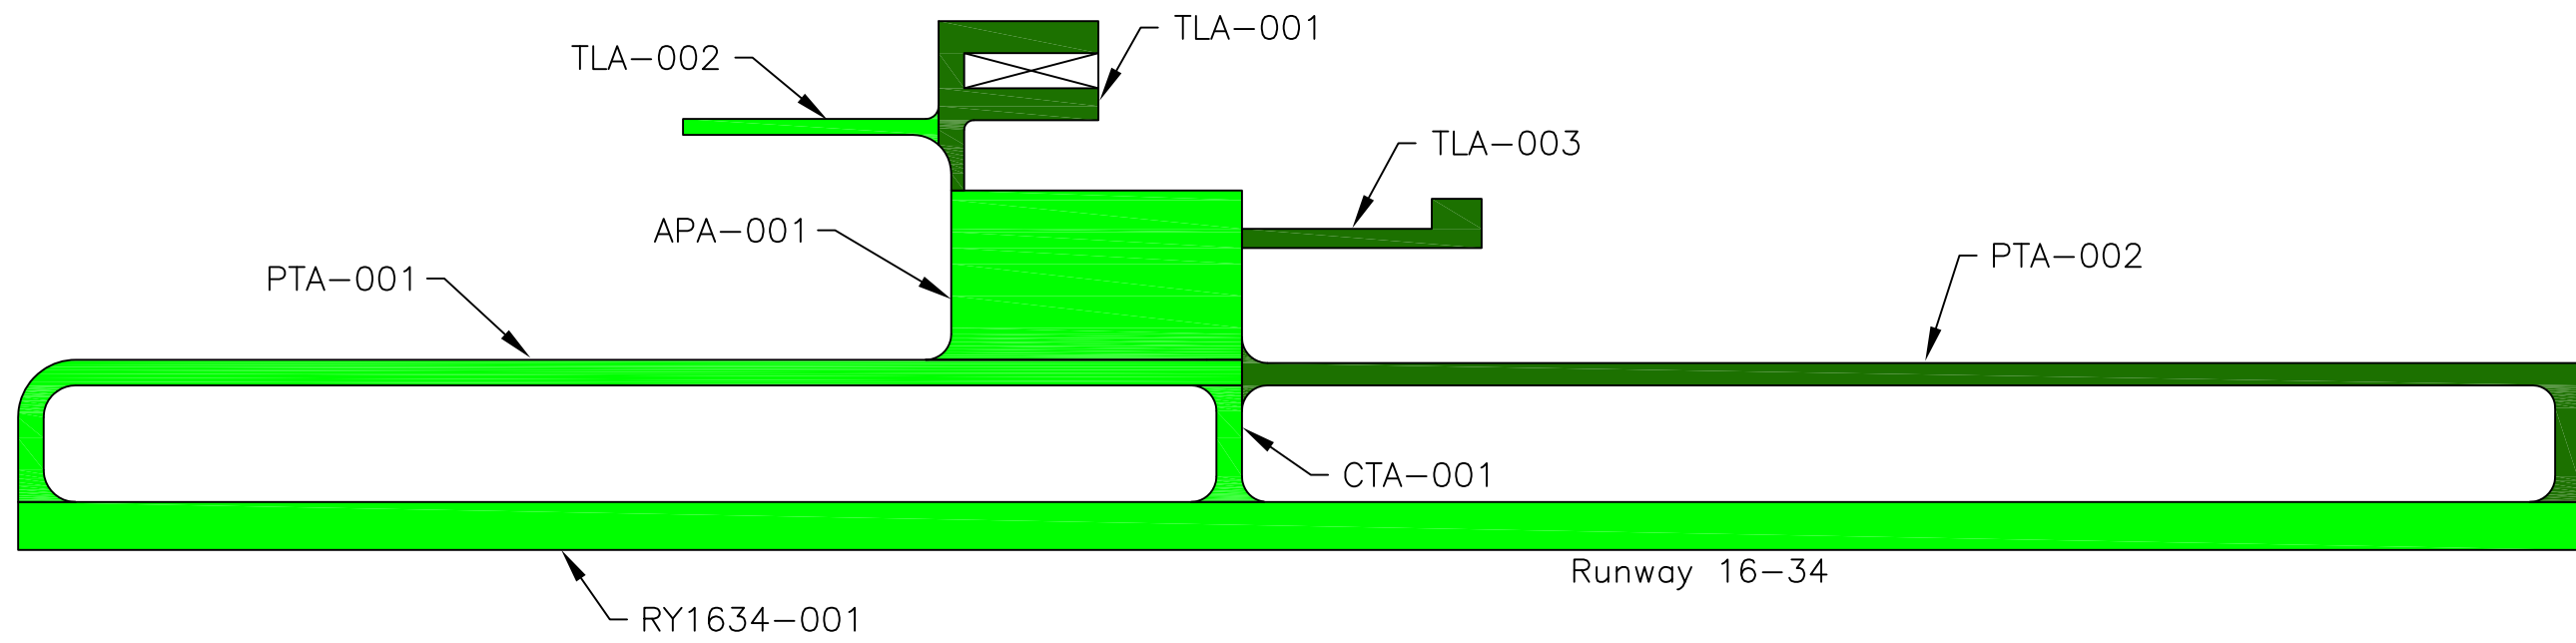
Figure 4. 2017 Pavement Condition Index Rating at Wadena Municipal Airport (ADC).

Figures 5 and 6 present the overall PCI for ADC by area distribution and pavement use, respectively. Table 3 presents the PCI summary for each section at ADC, including the drop in PCI per year. Generally, pavement sections will deteriorate between 1 and 3 PCI points per year. Sections deteriorating at higher rates may need maintenance above the normal application rates and should be closely monitored in case major repairs become necessary earlier than expected.

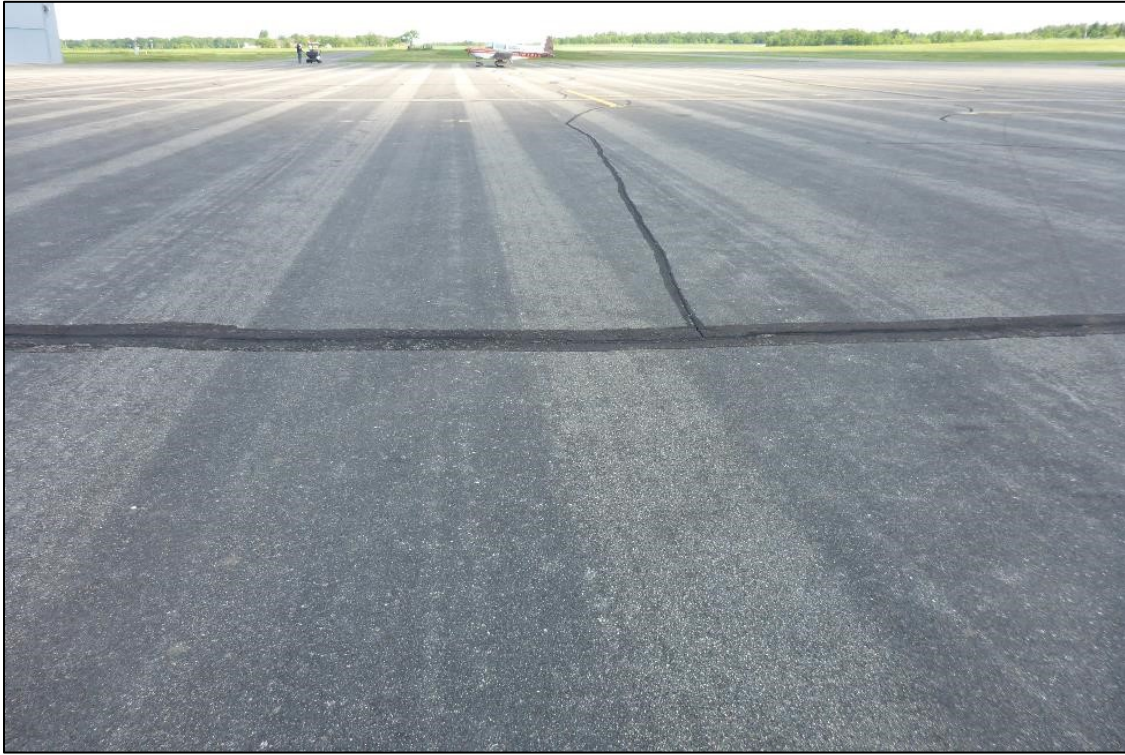
ADC APA 001 (PCI = 72)

Network: ADC				Name: WADENA		
Branch: APA	Name: APRON A	Use: APRON	Area: 119,250 SqFt			
Section: 001	of 1	From: 100	To: 604	Last Const.: 9/30/1998		
Surface: AC	Family: MN2013 Asphalt Aprons	Zone: W	Category: 1	Rank: S		
Area: 119,250 SqFt	Length: 450 Ft	Width: 265 Ft				
Slabs:	Slab Length: Ft	Slab Width: Ft	Joint Length: Ft			
Shoulder:	Street Type:	Grade: 0	Lanes: 0			
Last Insp. Date: 6/15/2017	Total Samples: 23	Surveyed: 5				
Conditions: PCI: 72						
Sample Number: 100	Type: R	Area: 5335.00 SqFt	PCI: 74			
48 L & T CR	M	120.00 Ft				
57 WEATHERING	L	2500.00 SqFt				
48 L & T CR	L	220.00 Ft				
Sample Number: 201	Type: R	Area: 5000.00 SqFt	PCI: 70			
57 WEATHERING	L	2500.00 SqFt				
48 L & T CR	M	82.00 Ft				
48 L & T CR	L	265.00 Ft				
50 PATCHING	L	200.00 SqFt				
Sample Number: 302	Type: R	Area: 5000.00 SqFt	PCI: 66			
57 WEATHERING	L	2500.00 SqFt				
50 PATCHING	L	150.00 SqFt				
48 L & T CR	L	340.00 Ft

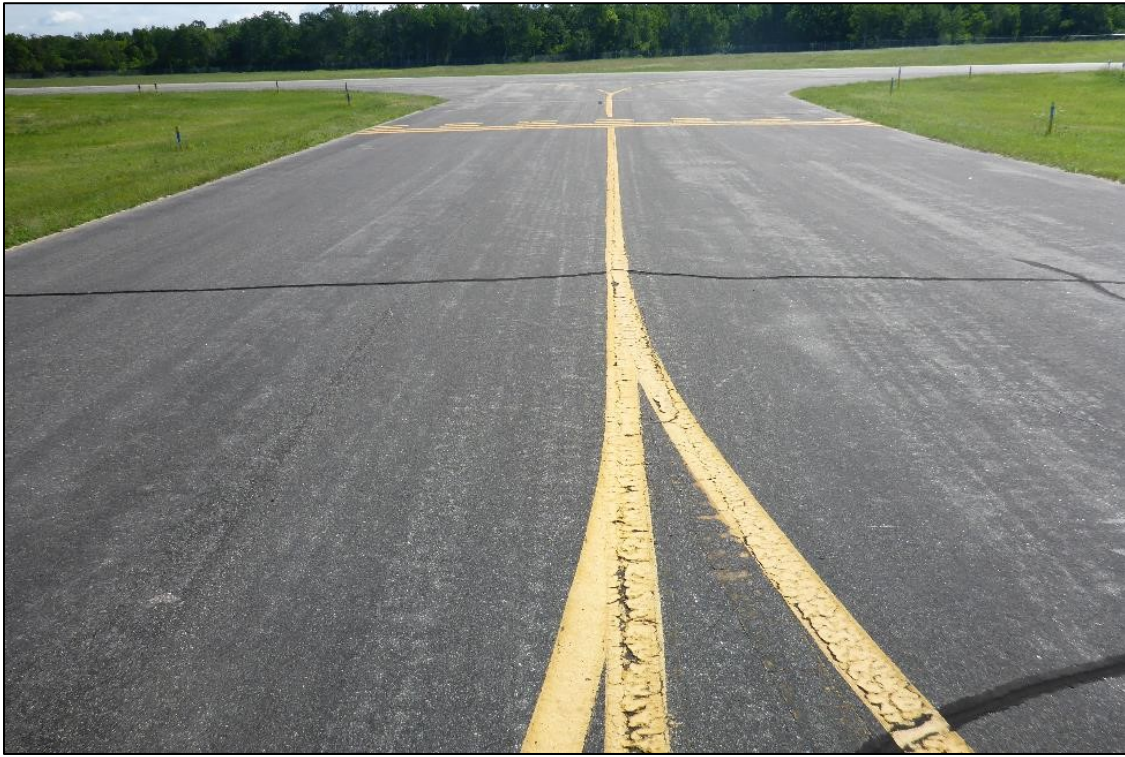
ADC CTA 001 (PCI = 84)

Network:	ADC	Name:	WADENA						
Branch:	CTA	Name:	CONNECTING TXWY A	Use:	TAXIWAY	Area:	8,400 SqFt		
Section:	001	of	1	From:	100	To:	101	Last Const.:	9/30/1998
Surface:	AC	Family:	MN2013 Asphalt Taxiways	Zone:	W	Category:	1	Rank:	P
Area:	8,400 SqFt	Length:	184 Ft	Width:	40 Ft				
Slabs:		Slab Length:	Ft	Slab Width:	Ft	Joint Length:	Ft		
Shoulder:		Street Type:		Grade:	0	Lanes:	0		
Last Insp. Date:	6/15/2017	Total Samples:	2	Surveyed:	2				
Conditions:	PCI: 84								
Sample Number:	100	Type:	R	Area:	4670.00 SqFt	PCI:	87		
50	PATCHING		L	160.00	SqFt				
48	L & T CR		L	73.00	Ft				
Sample Number:	101	Type:	R	Area:	3690.00 SqFt	PCI:	81		
48	L & T CR		L	174.00	Ft				
57	WEATHERING		L	1800.00	SqFt

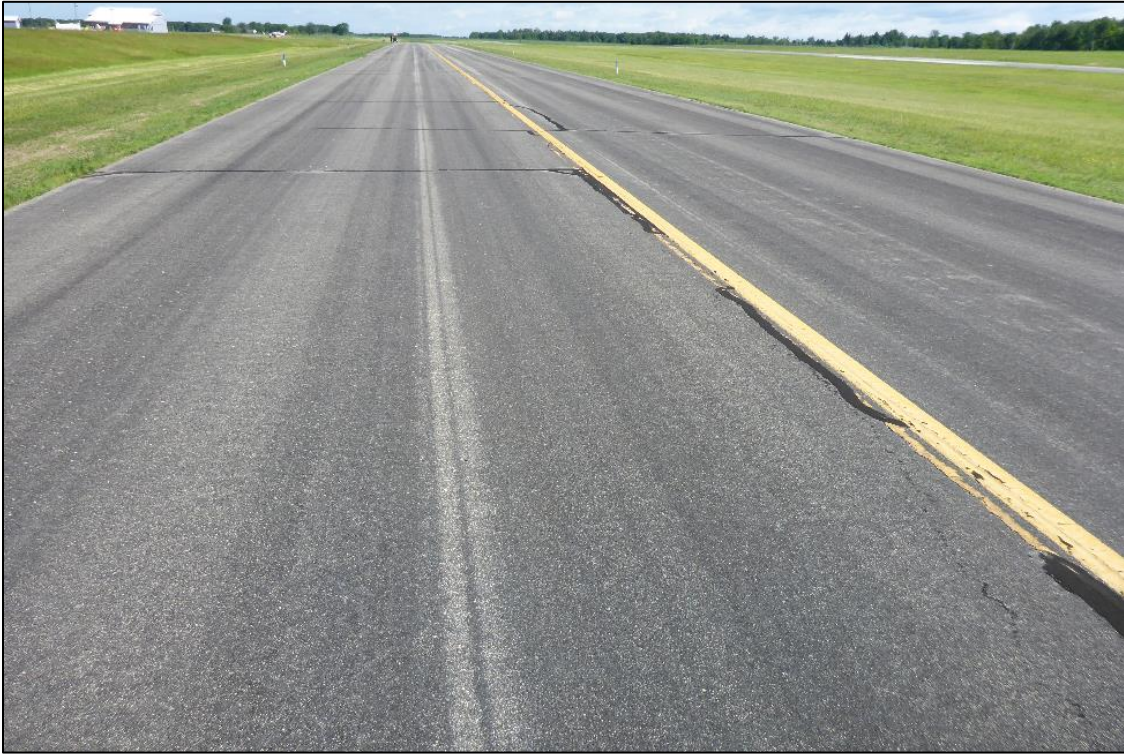
ADC PTA 001 (PCI = 74)

Network:	ADC	Name:	WADENA						
Branch:	PTA	Name:	PARALLEL TXWY A	Use:	TAXIWAY	Area:	163,600 SqFt		
Section:	001	of	2	From:	100	To:	120	Last Const.:	9/30/1998
Surface:	AC	Family:	MN2013 Asphalt Taxiways	Zone:	W	Category:	1	Rank:	P
Area:	82,600 SqFt	Length:	2,065 Ft	Width:	40 Ft				
Slabs:		Slab Length:	Ft	Slab Width:	Ft	Joint Length:	Ft		
Shoulder:		Street Type:		Grade:	0	Lanes:	0		
Last Insp. Date:	6/15/2017	Total Samples:	21	Surveyed:	4				
Conditions:	PCI: 74								
Sample Number:	102	Type:	R	Area:	4000.00 SqFt	PCI:	75		
57	WEATHERING	L		2000.00	SqFt				
48	L & T CR	M		36.00	Ft				
48	L & T CR	L		201.00	Ft				
Sample Number:	107	Type:	R	Area:	4000.00 SqFt	PCI:	73		
48	L & T CR	L		123.00	Ft				
48	L & T CR	M		98.00	Ft				
57	WEATHERING	L		2000.00	SqFt				
Sample Number:	112	Type:	R	Area:	4000.00 SqFt	PCI:	75		
48	L & T CR	L		228.00	Ft				
48	L & T CR	M		5.00	Ft				
57	WEATHERING	L		2000.00	SqFt				
Sample Number:	117	Type:	R	Area:	4000.00 SqFt	PCI:	71

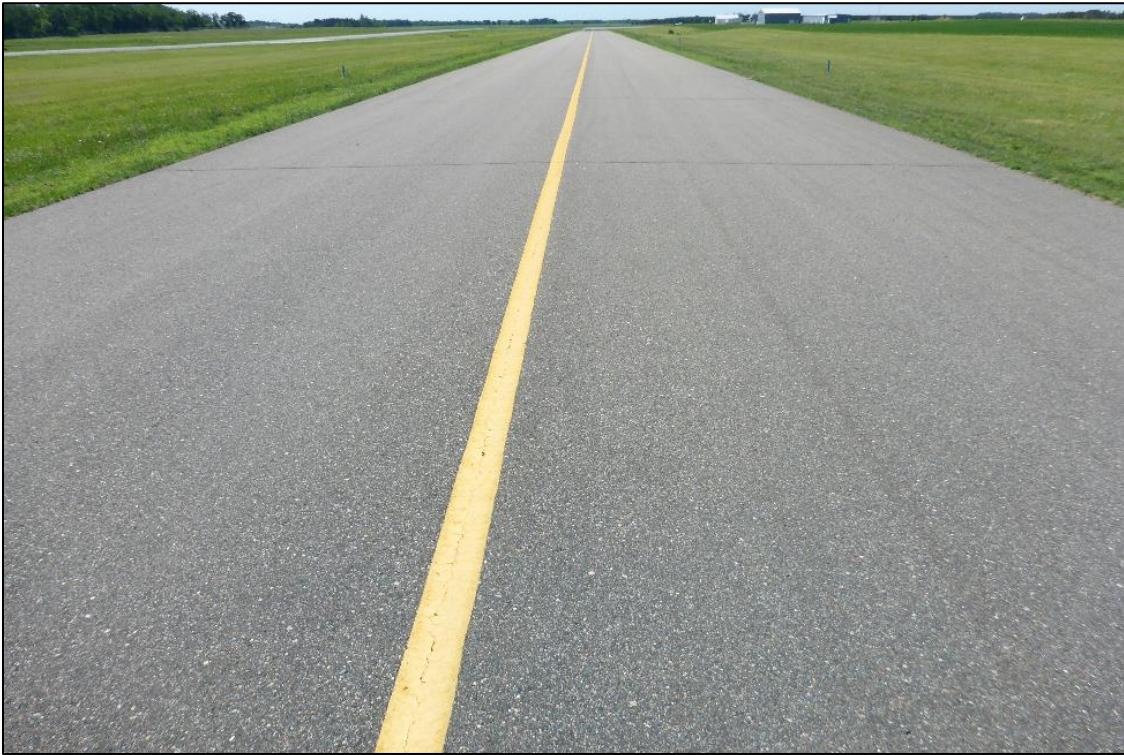
ADC PTA 002 (PCI = 89)

Network:	ADC	Name:	WADENA						
Branch:	PTA	Name:	PARALLEL TXWY A	Use:	TAXIWAY	Area:	163,600 SqFt		
Section:	002	of	2	From:	121	To:	RY 16	Last Const.:	6/1/2009
Surface:	AC	Family:	MN2013 Asphalt Taxiways	Zone:		Category:		Rank:	P
Area:	81,000 SqFt	Length:	2,090 Ft	Width:	35 Ft				
Slabs:		Slab Length:	Ft	Slab Width:	Ft	Joint Length:	Ft		
Shoulder:		Street Type:		Grade:	0	Lanes:	0		
Last Insp. Date:	6/15/2017	Total Samples:	21	Surveyed:	4				
Conditions:	PCI: 89								
Sample Number:	122	Type:	R	Area:	3500.00 SqFt	PCI:	68		
41	ALLIGATOR CR	L		60.00	SqFt				
57	WEATHERING	L		1000.00	SqFt				
48	L & T CR	L		2.00	Ft				
Sample Number:	127	Type:	R	Area:	3500.00 SqFt	PCI:	96		
57	WEATHERING	L		1000.00	SqFt				
Sample Number:	132	Type:	R	Area:	3500.00 SqFt	PCI:	96		
57	WEATHERING	L		1000.00	SqFt				
Sample Number:	137	Type:	R	Area:	3500.00 SqFt	PCI:	96		
57	WEATHERING	L		1000.00	SqFt

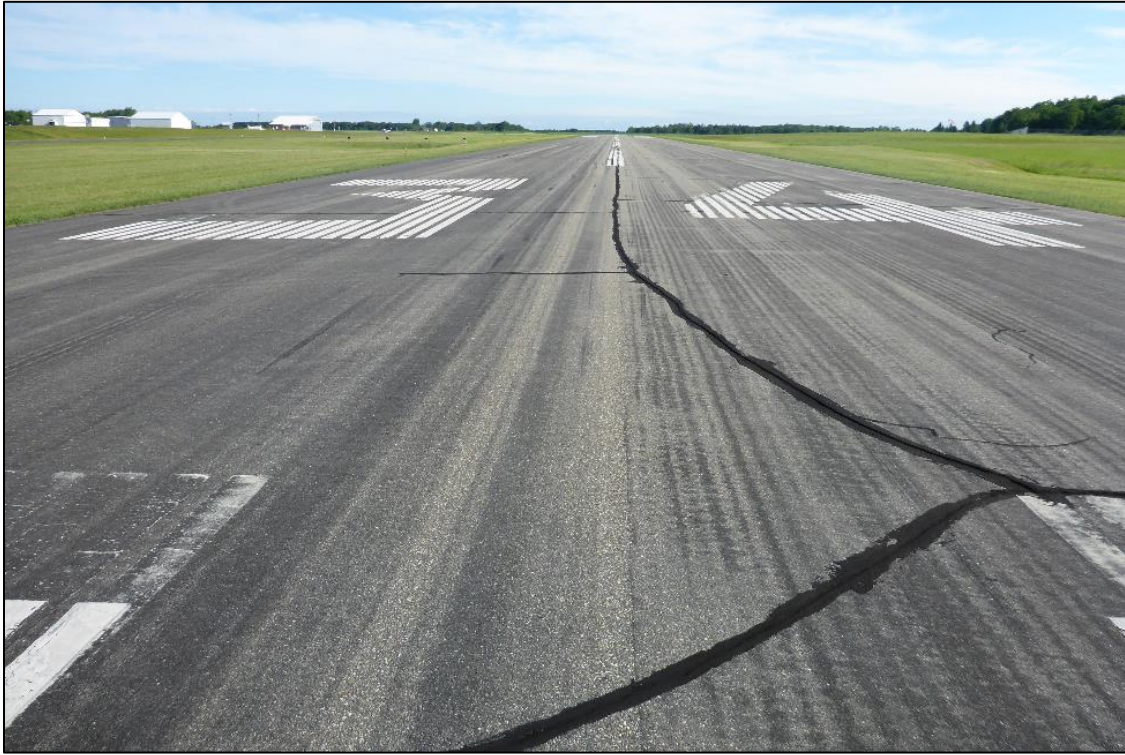
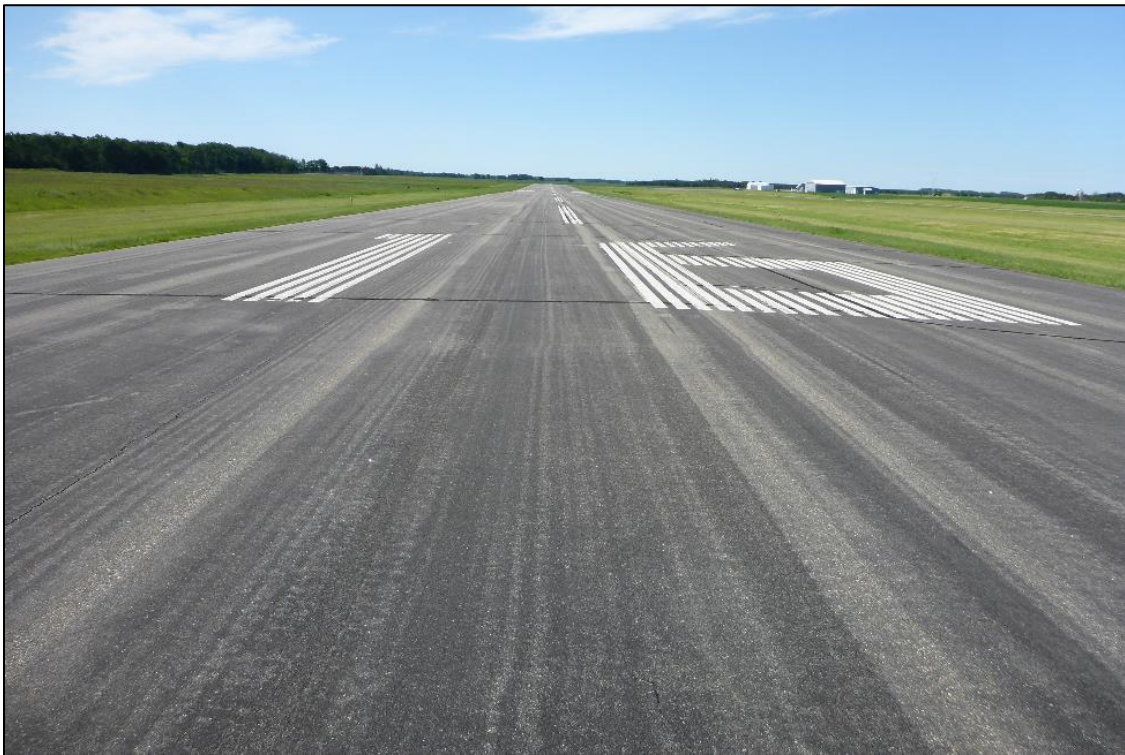
ADC RY1634 001 (PCI = 75)

Network:	ADC		Name:	WADENA					
Branch:	RY1634	Name:	RUNWAY 16-34	Use:	RUNWAY	Area:	300,400 SqFt		
Section:	001	of	1	From:	100	To:	179	Last Const.:	9/30/1998
Surface:	AC	Family:	MN2013 Asphalt Runways	Zone:	W	Category:	1	Rank:	P
Area:	300,400 SqFt	Length:	4,005 Ft	Width:	75 Ft				
Slabs:		Slab Length:	Ft	Slab Width:	Ft	Joint Length:	Ft		
Shoulder:		Street Type:		Grade:	0	Lanes:	0		
Last Insp. Date:	6/15/2017	Total Samples:	80	Surveyed:	8				
Conditions:	PCI: 75								
Sample Number:	104	Type:	R	Area:	3750.00 SqFt	PCI:	74		
48	L & T CR		M	23.00	Ft				
48	L & T CR		L	63.00	Ft				
48	L & T CR		L	153.00	Ft				
57	WEATHERING		L	1875.00	SqFt				
Sample Number:	115	Type:	R	Area:	3750.00 SqFt	PCI:	77		
50	PATCHING		L	300.00	SqFt				
48	L & T CR		L	150.00	Ft				
57	WEATHERING		L	1875.00	SqFt				
Sample Number:	124	Type:	R	Area:	3750.00 SqFt	PCI:	74		
48	L & T CR		L	221.00	Ft				
48	L & T CR		M	21.00	Ft				
57	WEATHERING		L	1875.00	SqFt

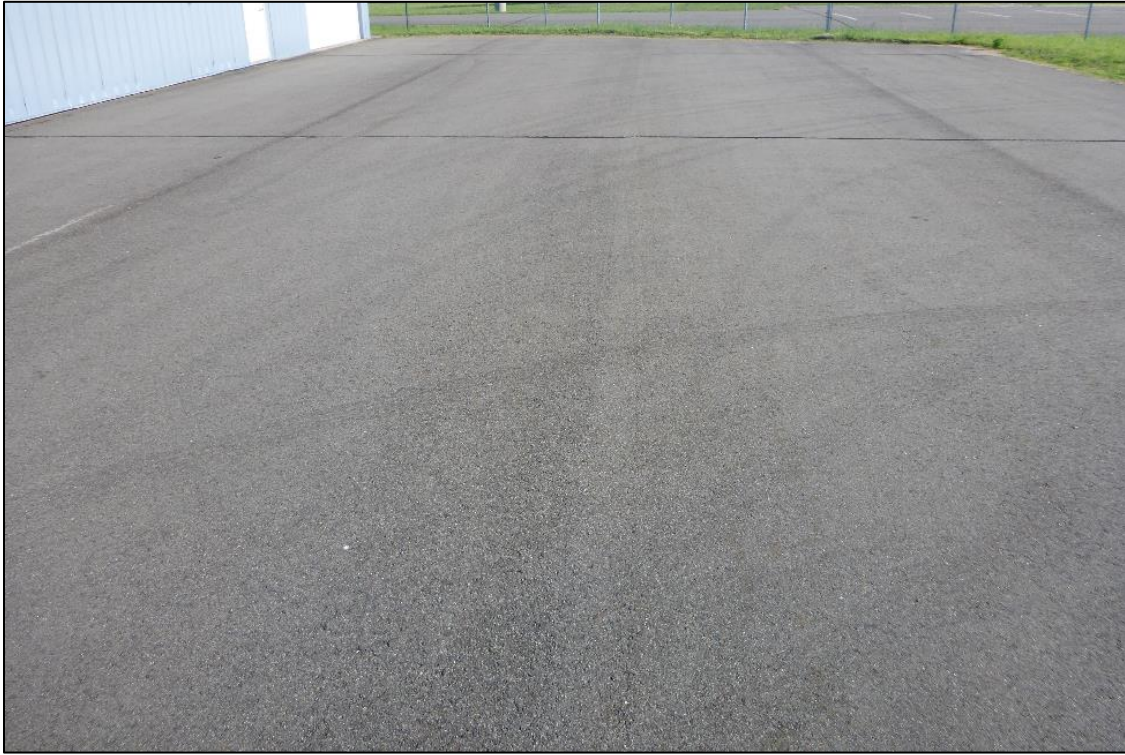
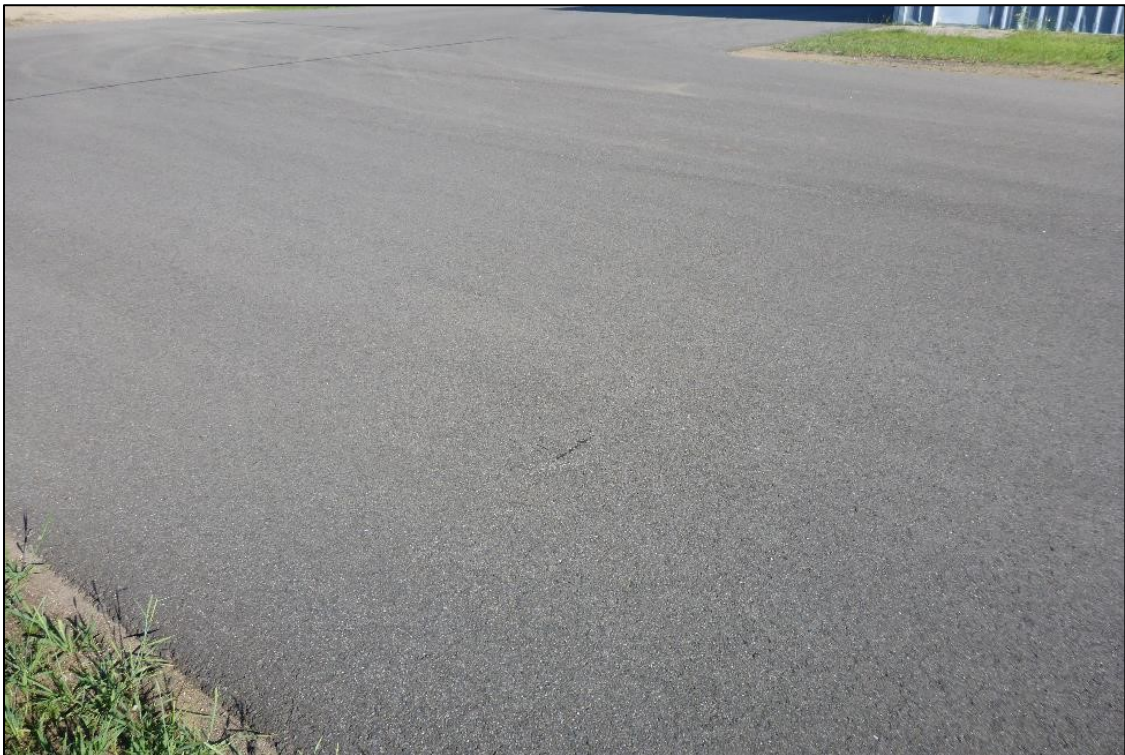
ADC TLA 001 (PCI = 98)

Network:	ADC	Name:	WADENA						
Branch:	TLA	Name:	TAXILANE A	Use:	TAXILANE	Area:	55,450 SqFt		
Section:	001	of 3	From:	100	To:	105	Last Const.: 6/30/2016		
Surface:	AC	Family:	MN2013 Asphalt Taxilanes	Zone:	W	Category:	1	Rank:	T
Area:	30,500 SqFt	Length:	200 Ft	Width:	100 Ft				
Slabs:		Slab Length:	Ft	Slab Width:	Ft	Joint Length:	Ft		
Shoulder:		Street Type:		Grade:	0	Lanes:	0		
Last Insp. Date:	6/15/2017	Total Samples:	6	Surveyed:	3				
Conditions:	PCI: 98								
Sample Number:	101	Type:	R	Area:	5000.00 SqFt	PCI:	99		
57	WEATHERING		M		12.00 SqFt				
Sample Number:	103	Type:	R	Area:	5550.00 SqFt	PCI:	100		
<No Distress>									
Sample Number:	104	Type:	R	Area:	5500.00 SqFt	PCI:	95		
48	L & T CR		L		48.00 Ft

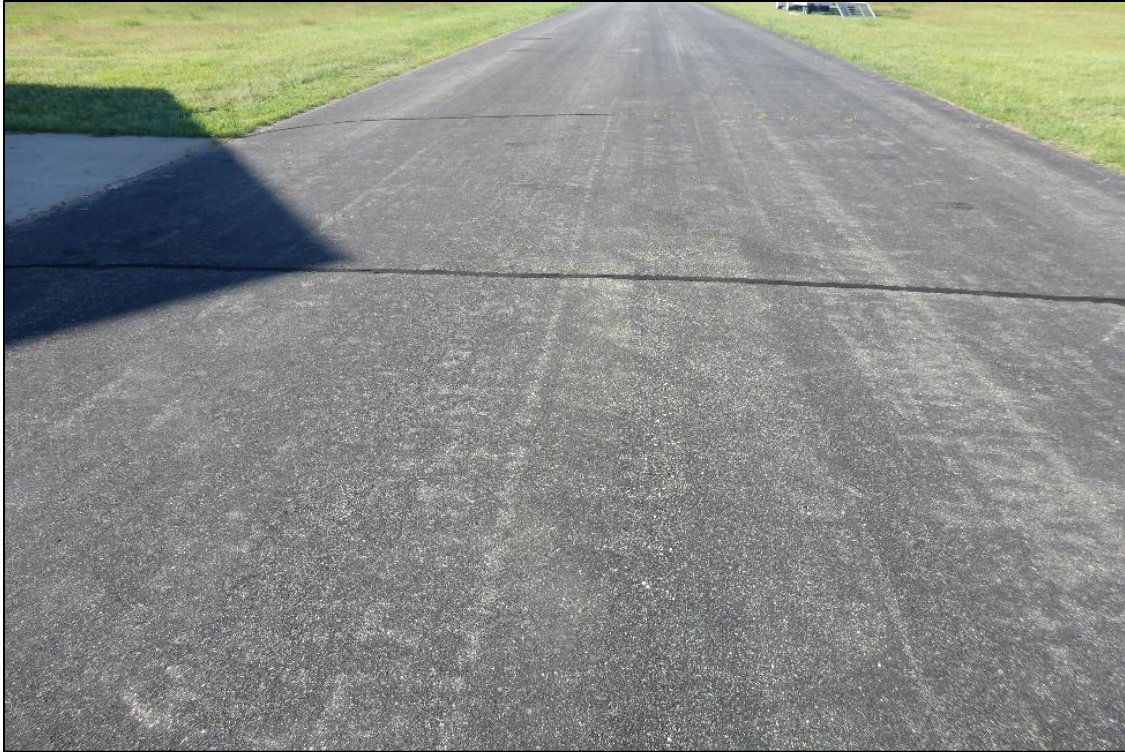
ADC TLA 002 (PCI = 84)

Network:	ADC	Name:	WADENA						
Branch:	TLA	Name:	TAXILANE A	Use:	TAXILANE	Area:	55,450 SqFt		
Section:	002	of	3	From:	100	To:	102	Last Const.:	11/1/2005
Surface:	AC	Family:	MN2013 Asphalt Taxilanes	Zone:	W	Category:	1	Rank:	T
Area:	10,300 SqFt	Length:	400 Ft	Width:	25 Ft				
Slabs:		Slab Length:	Ft	Slab Width:	Ft	Joint Length:	Ft		
Shoulder:		Street Type:		Grade:	0	Lanes:	0		
Last Insp. Date:	6/15/2017	Total Samples:	2	Surveyed:	1				
Conditions:	PCI: 84								
Sample Number:	100	Type:	R	Area:	5000.00 SqFt	PCI:	84		
48	L & T CR		L	123.00	Ft				
48	L & T CR		M	49.00	Ft

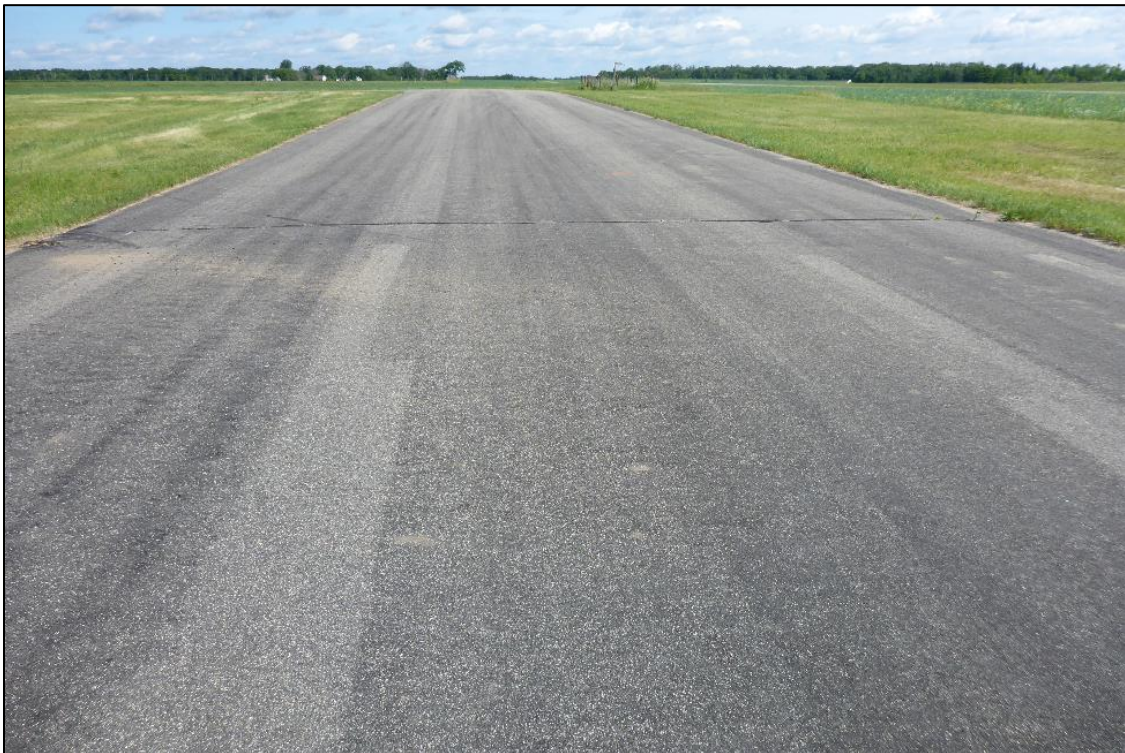
ADC TLA 003 (PCI = 87)

Network:	ADC	Name:	WADENA						
Branch:	TLA	Name:	TAXILANE A	Use:	TAXILANE	Area:	55,450 SqFt		
Section:	003	of	3	From:	100	To:	102	Last Const.:	11/1/1998
Surface:	AC	Family:	MN2013 Asphalt Taxilanes	Zone:	W	Category:	1	Rank:	T
Area:	14,650 SqFt	Length:	300 Ft	Width:	30 Ft				
Slabs:		Slab Length:	Ft	Slab Width:	Ft	Joint Length:	Ft		
Shoulder:		Street Type:		Grade:	0	Lanes:	0		
Last Insp. Date:	6/15/2017	Total Samples:	3	Surveyed:	2				
Conditions:	PCI: 87								
Sample Number:	100	Type:	R	Area:	4500.00 SqFt	PCI:	84		
48	L & T CR		M	60.00	Ft				
57	WEATHERING		L	1000.00	SqFt				
Sample Number:	102	Type:	R	Area:	5625.00 SqFt	PCI:	89		
48	L & T CR		M	32.00	Ft				
57	WEATHERING		L	1000.00	SqFt
