Pavement Condition Report

Springfield Municipal Airport (D42)

December 2018

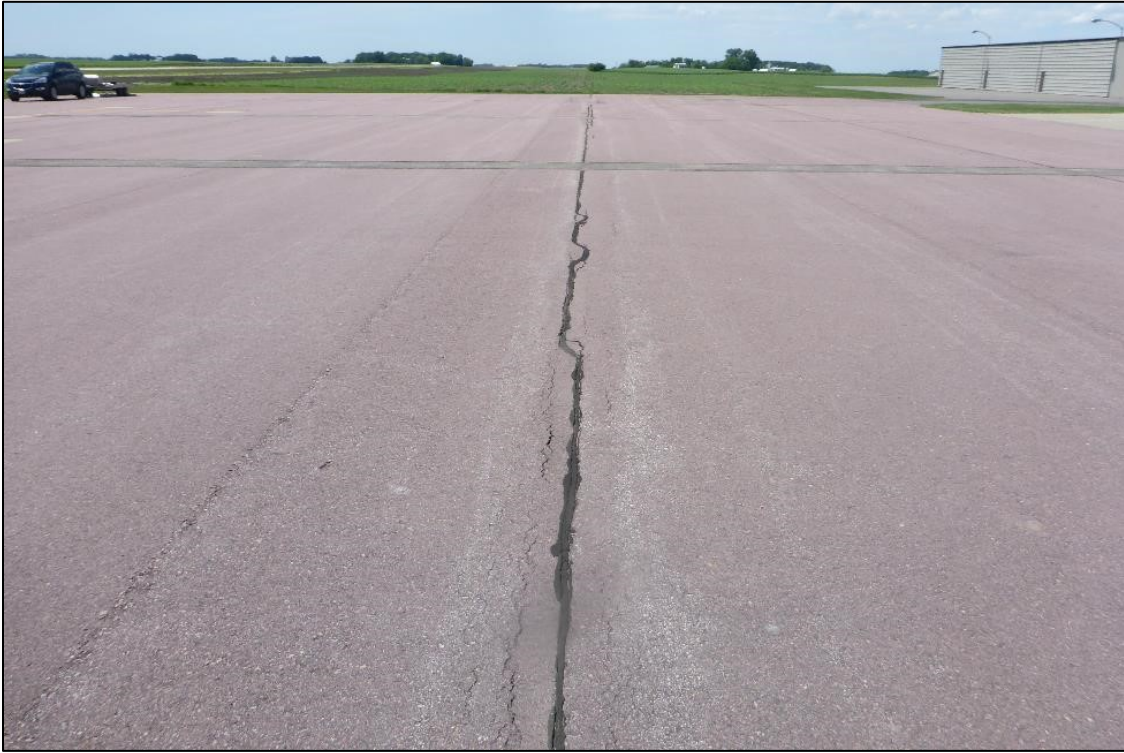
D42 APA 001 (PCI = 74)

Network: D42						Name: SPRINGFIELD
Branch: APA	Name: APRON A	Use: APRON	Area: 75,000 SqFt			
Section: 001	of 1	From: 305	To: 509	Last Const.: 8/31/2009		
Surface: AC	Family: MN2018 Asphalt Aprons	Zone: S	Category: 2	Rank: S		
Area: 75,000 SqFt	Length: 500 Ft	Width: 150 Ft				
Slabs:	Slab Length: Ft	Slab Width: Ft	Joint Length: Ft			
Shoulder:	Street Type:	Grade: 0	Lanes: 0			
Last Insp. Date: 6/4/2018	Total Samples: 15	Surveyed: 5				
Conditions: PCI: 74						
Sample Number: 305	Type: R	Area: 5000.00 SqFt	PCI: 71			
48 L & T CR	M	192.00 Ft				
50 PATCHING	L	14.00 SqFt				
48 L & T CR	L	167.00 Ft				
Sample Number: 309	Type: R	Area: 5000.00 SqFt	PCI: 79			
48 L & T CR	M	51.00 Ft				
48 L & T CR	L	113.00 Ft				
41 ALLIGATOR CR	L	11.00 SqFt				
Sample Number: 406	Type: R	Area: 5000.00 SqFt	PCI: 73			
48 L & T CR	H	19.00 Ft				
48 L & T CR	M	85.00 Ft				
50 PATCHING	L	300.00 SqFt				
48 L & T CR	L	37.00 Ft				
Sample Number: 408	Type: R	Area: 5000.00 SqFt	PCI: 74

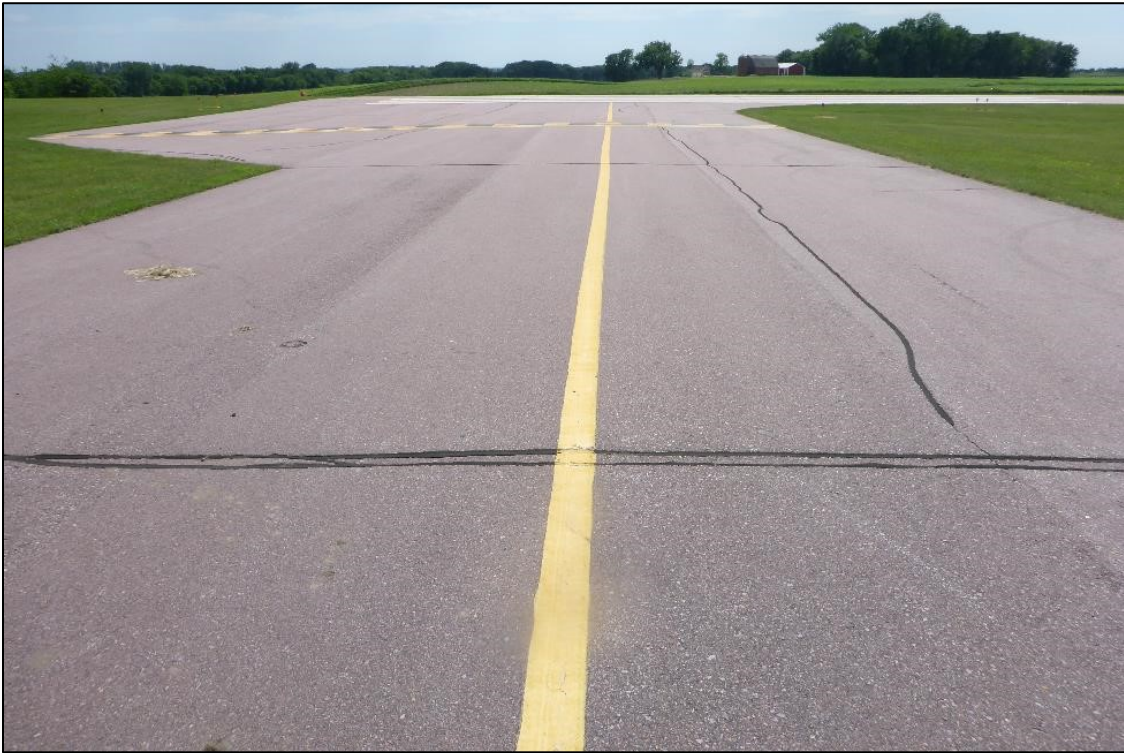
D42 CTA 001 (PCI = 77)

Network:	D42	Name:	SPRINGFIELD				
Branch:	CTA	Name:	CONNECTING TAXIWAY A	Use:	TAXIWAY	Area:	15,600 SqFt
Section:	001	of 1	From:	200	To:	201	Last Const.: 8/31/2009
Surface:	AC	Family:	MN2018 Asphalt Runway- Taxiways	Zone:	S	Category:	2 Rank: P
Area:	15,600 SqFt	Length:	240 Ft	Width:	50 Ft		
Slabs:		Slab Length:	Ft	Slab Width:	Ft	Joint Length:	Ft
Shoulder:		Street Type:		Grade:	0	Lanes:	0
Last Insp. Date:	6/4/2018	Total Samples:	3	Surveyed:	2		
Conditions:	PCI: 77						
Sample Number:	200	Type:	R	Area:	4325.00 SqFt	PCI:	72
48	L & T CR		L	107.00 Ft			
50	PATCHING		L	104.00 SqFt			
48	L & T CR		M	107.00 Ft			
Sample Number:	201	Type:	R	Area:	5600.00 SqFt	PCI:	81
48	L & T CR		L	121.00 Ft			
48	L & T CR		M	88.00 Ft

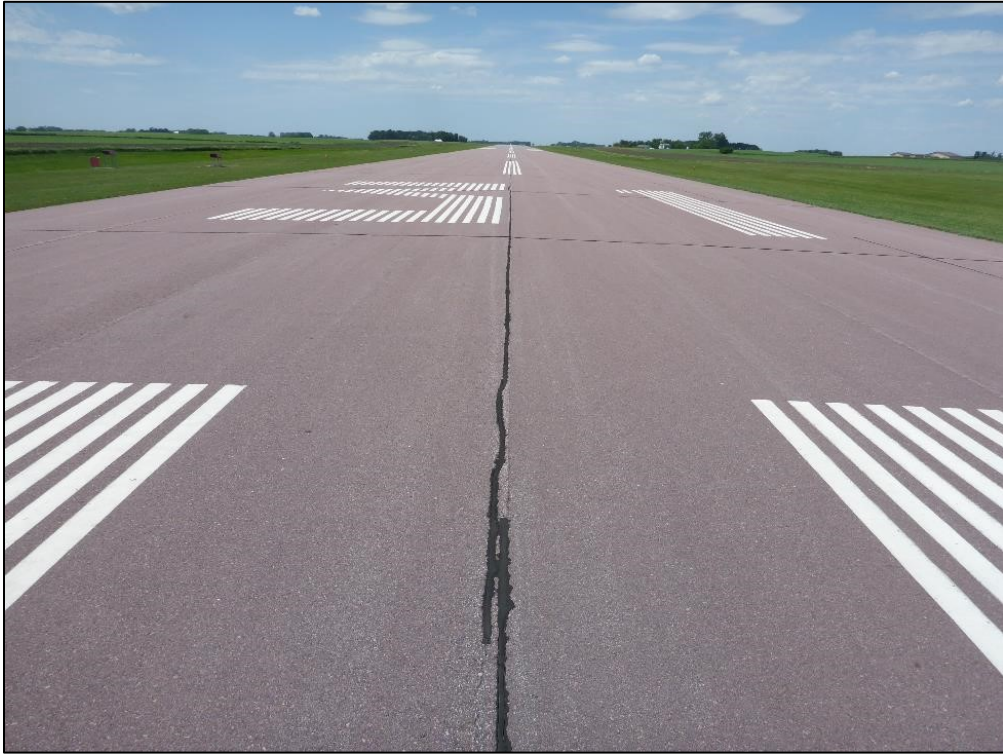
D42 RY1331 001 (PCI = 77)

Network:	D42		Name:	SPRINGFIELD					
Branch:	RY1331	Name:	RUNWAY 13-31	Use:	RUNWAY	Area:	267,400 SqFt		
Section:	001	of 1	From:	100	To:	167	Last Const.:	8/31/2009	
Surface:	AC	Family:	MN2018 Asphalt Runway-Taxiways	Zone:	S	Category:	2	Rank:	P
Area:	267,400 SqFt	Length:	3,400 Ft	Width:	75 Ft				
Slabs:		Slab Length:	Ft	Slab Width:	Ft	Joint Length:	Ft		
Shoulder:		Street Type:		Grade:	0	Lanes:	0		
Last Insp. Date:	6/4/2018	TotalSamples:	70	Surveyed:	7				
Conditions:	PCI: 77								
Sample Number:	104	Type:	R	Area:	3750.00 SqFt	PCI:	78		
48	L & T CR	M		85.00	Ft				
48	L & T CR	L		177.00	Ft				
Sample Number:	114	Type:	R	Area:	3750.00 SqFt	PCI:	75		
48	L & T CR	M		73.00	Ft				
48	L & T CR	L		50.00	Ft				
48	L & T CR	H		2.00	Ft				
Sample Number:	122	Type:	R	Area:	3750.00 SqFt	PCI:	77		
48	L & T CR	M		115.00	Ft				
48	L & T CR	L		40.00	Ft				
Sample Number:	132	Type:	R	Area:	3750.00 SqFt	PCI:	77		
48	L & T CR	L		97.00	Ft

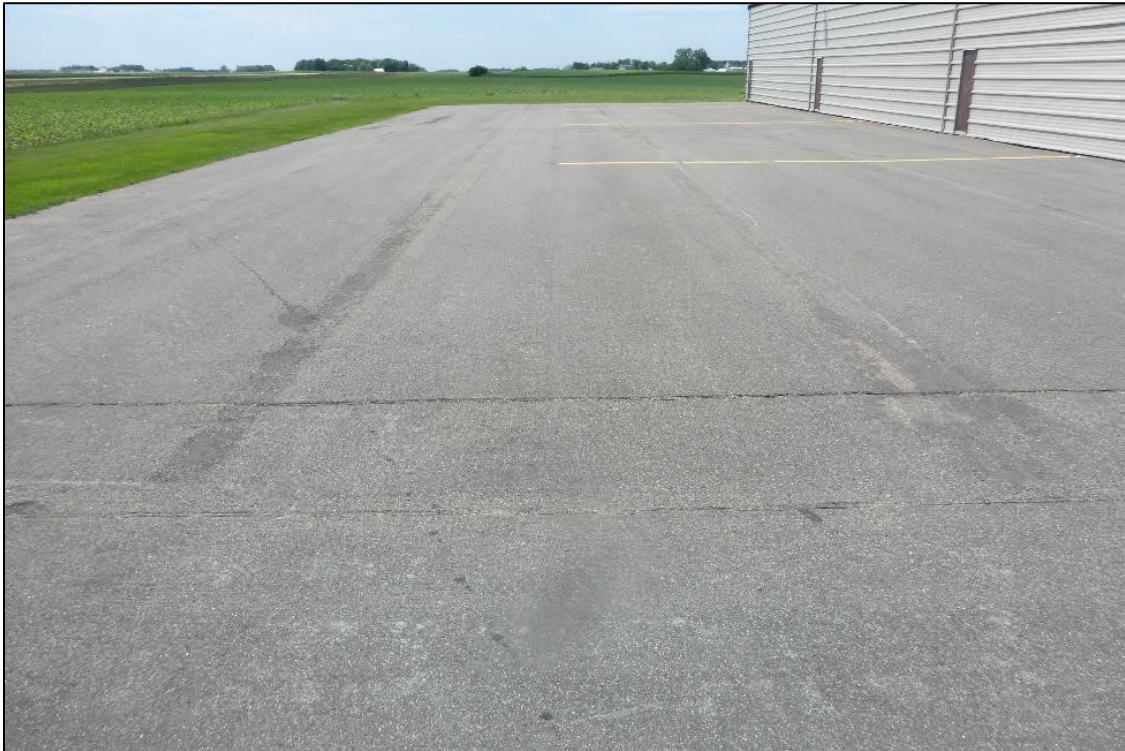
D42 TLA 001 (PCI = 72)

Network:	D42		Name:	SPRINGFIELD					
Branch:	TLA	Name:	Taxilane A	Use:	TAXILANE	Area:	23,100 SqFt		
Section:	001	of 1	From:	604	To:	806	Last Const.:	9/30/1994	
Surface:	AAC	Family:	MN2018 Asphalt Taxilanes	Zone:	S	Category:	2	Rank:	T
Area:	23,100 SqFt	Length:	390 Ft	Width:	50 Ft				
Slabs:		Slab Length:	Ft	Slab Width:	Ft	Joint Length:	Ft		
Shoulder:		Street Type:		Grade:	0	Lanes:	0		
Last Insp. Date:	6/4/2018	TotalSamples:	5	Surveyed:	1				
Conditions:	PCI: 72								
Sample Number:	605	Type:	R	Area:	5000.00 SqFt	PCI:	72		
49	OIL SPILLAGE	N		550.00	SqFt				
48	L & T CR	L		62.00	Ft				
50	PATCHING	L		300.00	SqFt
