Construction Report for a Thin Unbonded Concrete Overlay on Minnesota TH 53

Interim Report

July 2010

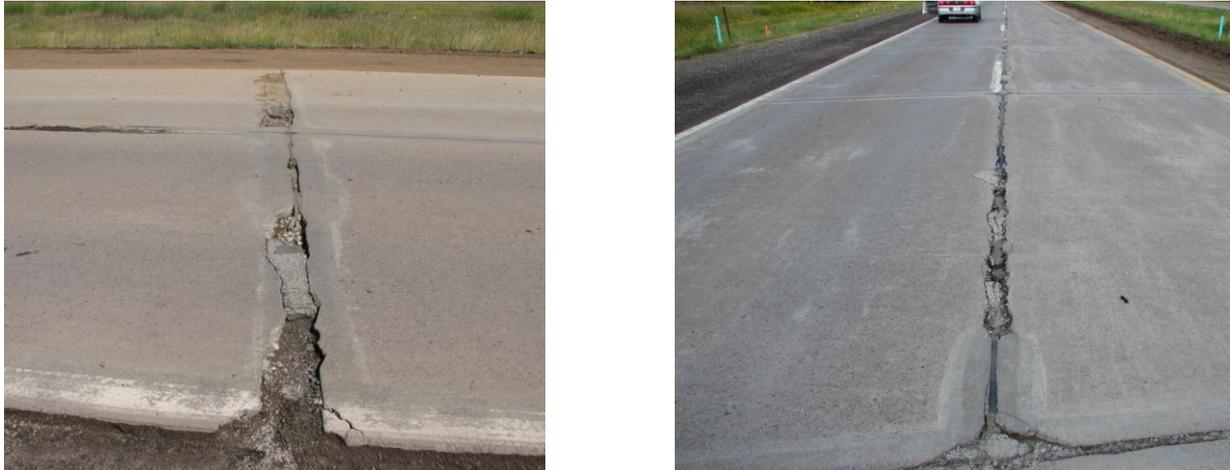
Prior to overlay construction, the pavement had received two concrete pavement repair (CPR) operations, which included joint sealant removal and replacement in 1983 and joint repair in 1992. Figure 3.4 shows transverse and longitudinal joint condition prior to overlay placement in 2008 (note that the repair treatments are still visible). Some joints had deteriorated down to the base material.

Figure 3.4. Typical Transverse and Longitudinal Joint Condition Prior to Overlay

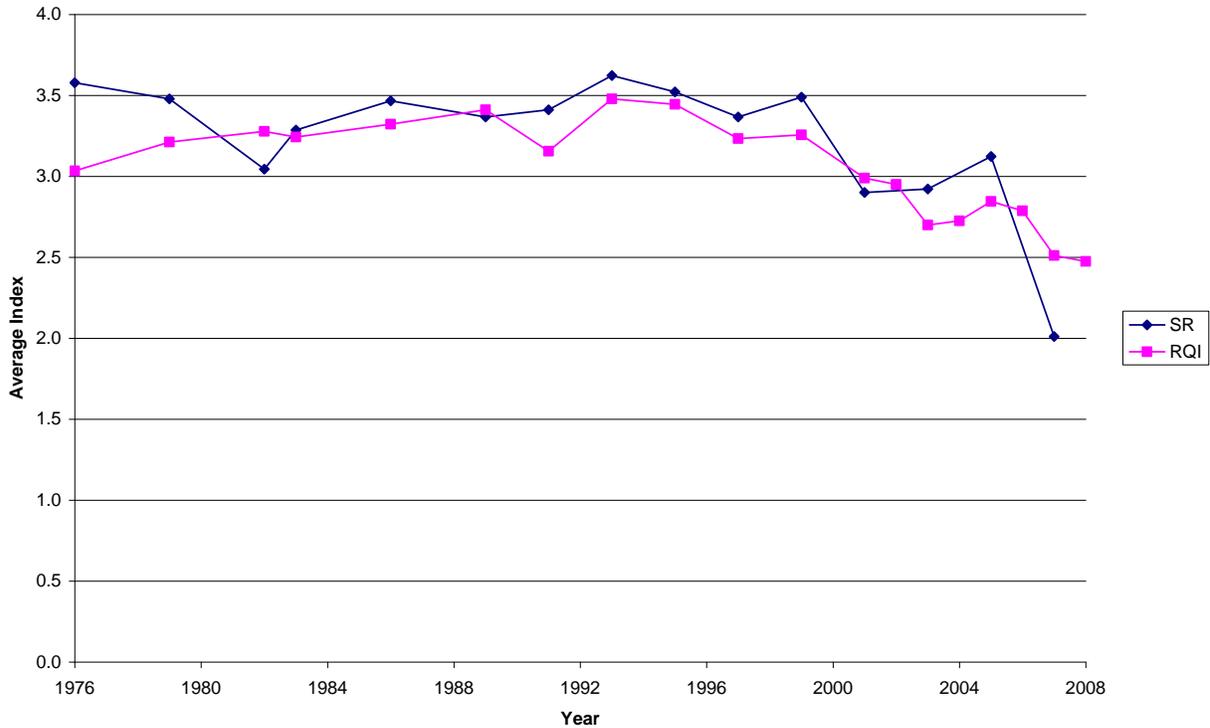
Pavement performance data on ride and distress has been gathered routinely on the trunk highway (TH) system in Minnesota since 1976. Two important measures gathered are the surface rating (SR), which is a rating of visual distresses on a scale of 0.0 to 4.0 (a 4.0 represents a road with no visible distresses), and ride quality index (RQI), which is an indication of pavement roughness on a scale of 0.0 to 5.0, as described in Table 3.1. Figure 3.5 shows the average surface rating (SR) and ride quality index (RQI) recorded by the Mn/DOT Pavement Management Section for TH 53. Note that just prior to the concrete overlay, the RQI had deteriorated to a “fair” condition, and the SR had deteriorated to a level of 2.0, which is lower than the commonly accepted default threshold value of 2.5 or “fair condition”.

Figure 3.5. Average Pavement Condition Prior to Overlay

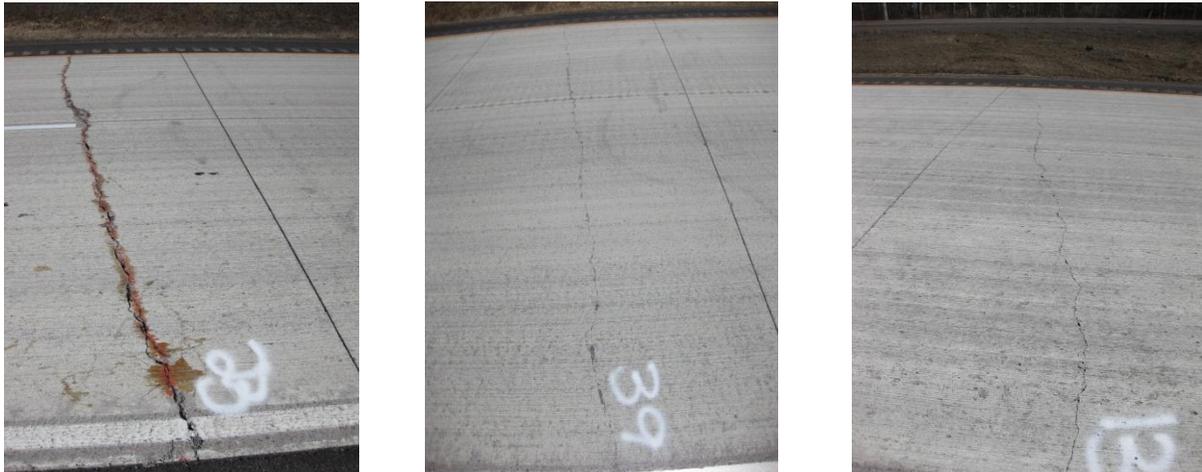
In spring 2009, a detailed visual distress survey was carried out (over the entire 9+ project length) to ascertain both the number and condition of distresses present in the overlay after the first winter. The survey found that approximately 40 cracks had formed in the overlay, with severity ratings of: 7% high, 41% medium, and 51% low. Figure 5.2 shows a qualitative depiction of the different severity levels.

Figure 5.2. From Left to Right: High (3), Medium (2) and Low (1) Severity Cracking

Based on the random occurrence of the transverse cracks through the panels, it is deduced they were likely caused by late sawing of the joints. It seems that paving the thin concrete overlay progressed much faster than the capabilities of the sawing equipment on site. The higher surface to thickness ratio of the overlay also presented additional challenges in timing the saw cuts. The skewed nature of some of the cracks (Figure 4.3, rightmost photo) leads one to believe they are more reflective in nature. In addition to transverse cracking through the panels, the fall 2009 survey also revealed the presence of other distresses, notably joint spalling, which was again most likely caused by improper timing (early) of the joint sawing. It should be noted that no mid panel cracks have appeared in the overlay section with 6 foot by 6 foot panels.

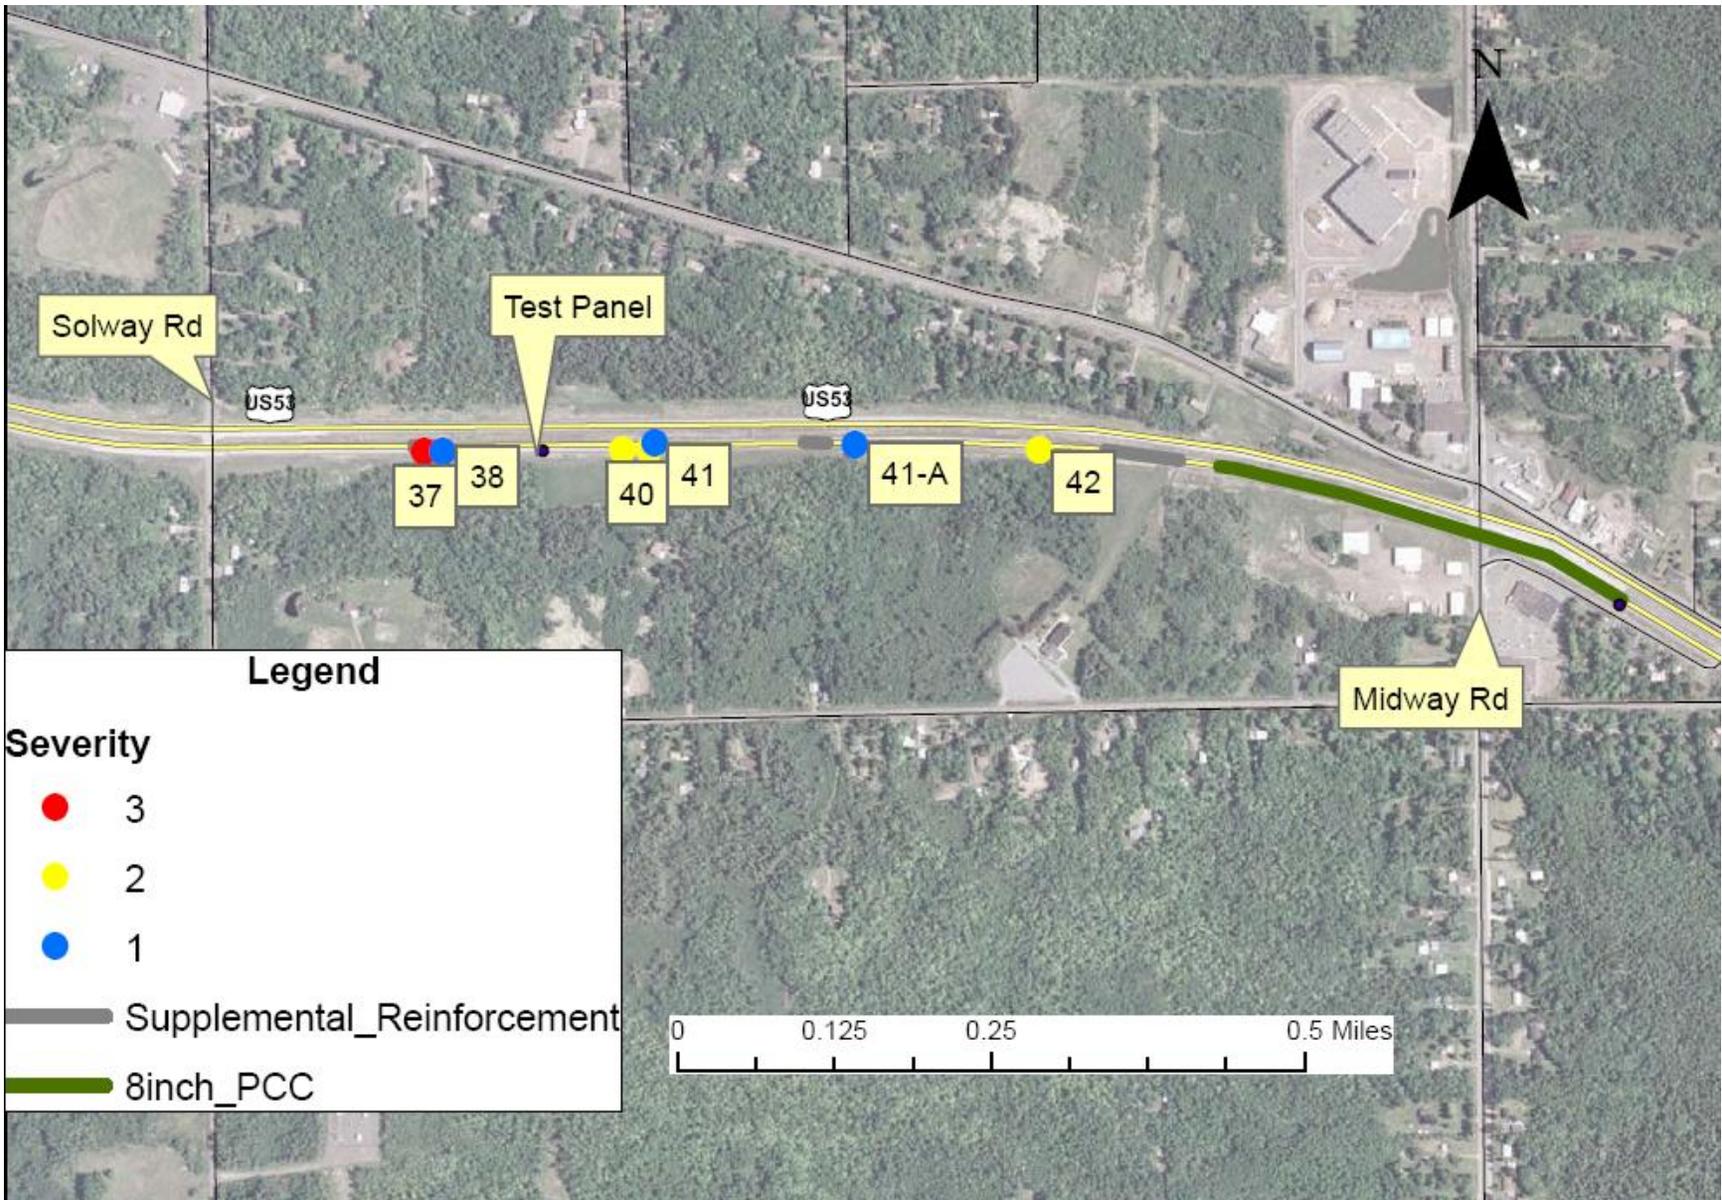
Figure 5.3. TH 53 Distress Map [Midway Rd to Solway Rd], April 2009

Figure 5.3 to Figure 5.7 show the locations of surface distresses observed during the second distress survey, conducted in August 2009. The distresses were visually rated for severity (Figure 5.2). Note that 3, 2 and 1 denote high, medium and low severity cracking, respectively. Each crack was assigned an I.D. number that can be used to reference a picture of the distress in Appendix A. These figures also show locations of the full depth (8 inch thick) concrete pavement sections constructed on TH 53, and the approximate locations of the supplemental panel reinforcement installed over excessively cracked portions of the original concrete pavement. Note that the fall survey was only conducted on half of the project length, due to restrictions that arose from construction of a similar TUBOL on the adjacent northbound lanes of TH 53.
