Pavement Condition Report

Waseca Municipal Airport (ACQ)

December 2016

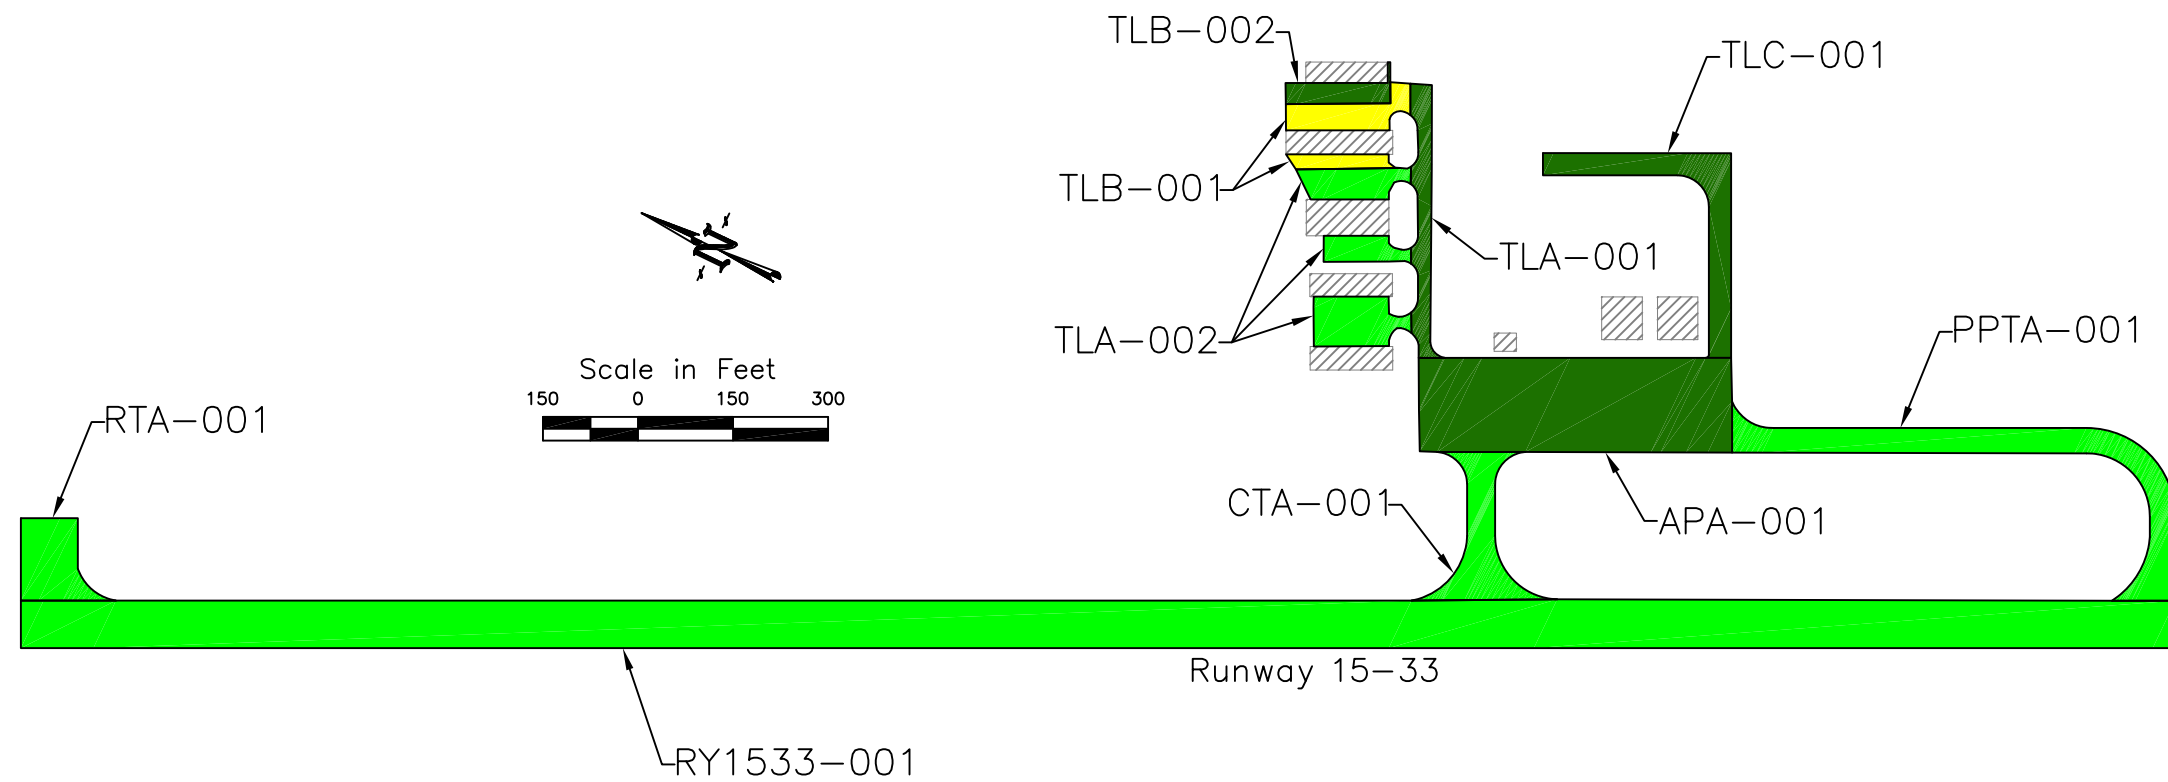
Figure 4. 2016 Pavement Condition Index Rating at Waseca Municipal Airport (ACQ).

The results of the 2016 PCI inspection are presented in figure 4. The overall area-weighted, inspected PCI for ACQ is 83. When summarizing PCI values, an area-weighted calculation is used instead of a straight mathematical average because the area-weighted calculations eliminate the skewing of the PCI due to the disparity of the section sizes.

Local maintenance like crack sealing and patching as well as slurry seals have occurred at the airport since the last inspection resulting in higher PCIs for some sections.
