Pavement Condition Report

Springfield Municipal Airport (D42)

December 2018

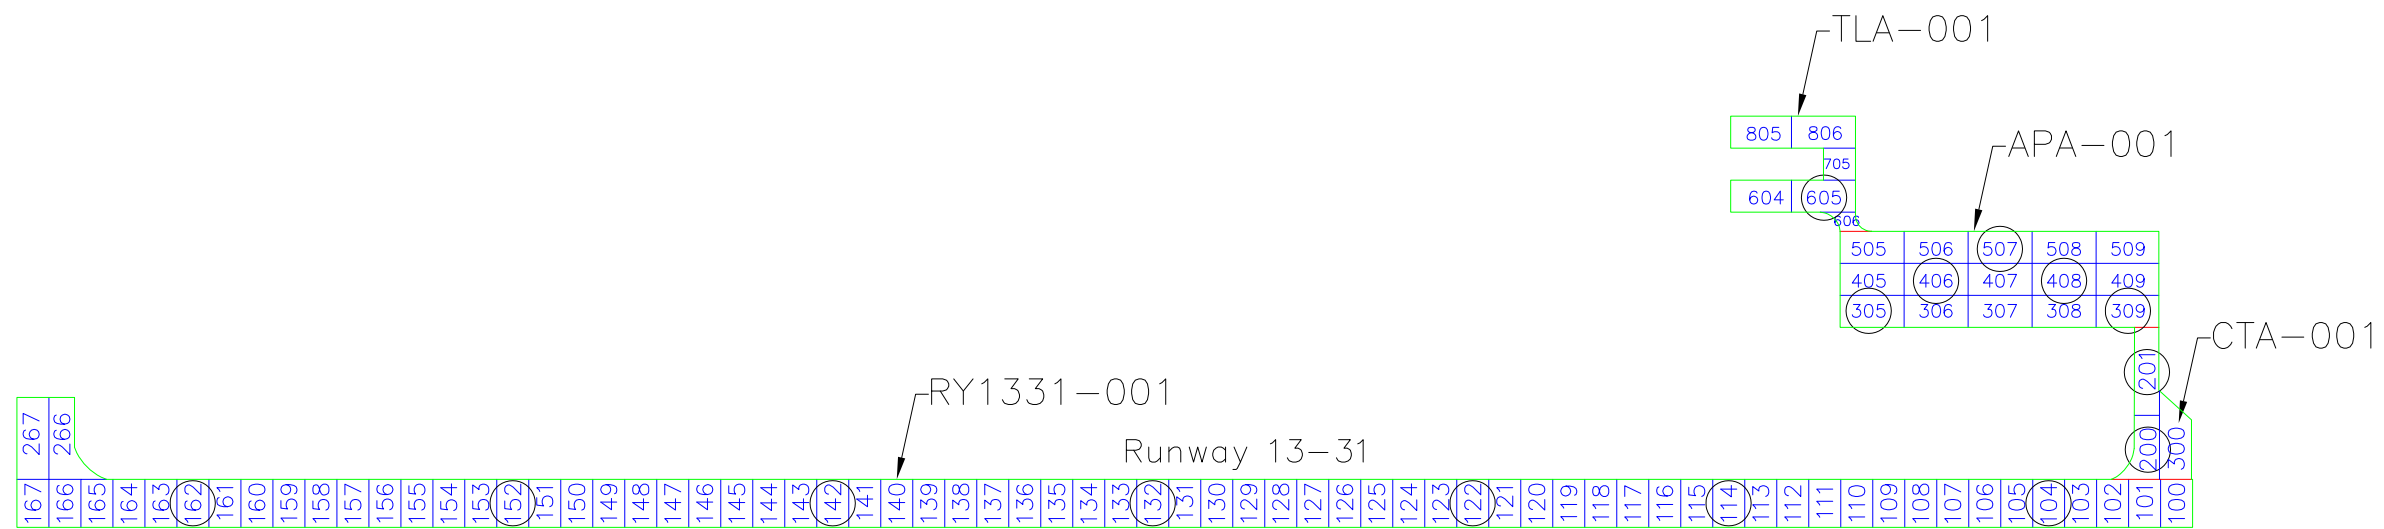
Sample Unit Layout Springfield Municipal Airport (D42)			
ENGINEER: BDA	DRAWN BY: MJP	DATE: JUL 2018	CTAF 122.8

- Denotes sample unit surveyed
- ◇ Denotes additional sample unit surveyed
