Construction Report for a Thin Unbonded Concrete Overlay on Minnesota TH 53

Interim Report

July 2010

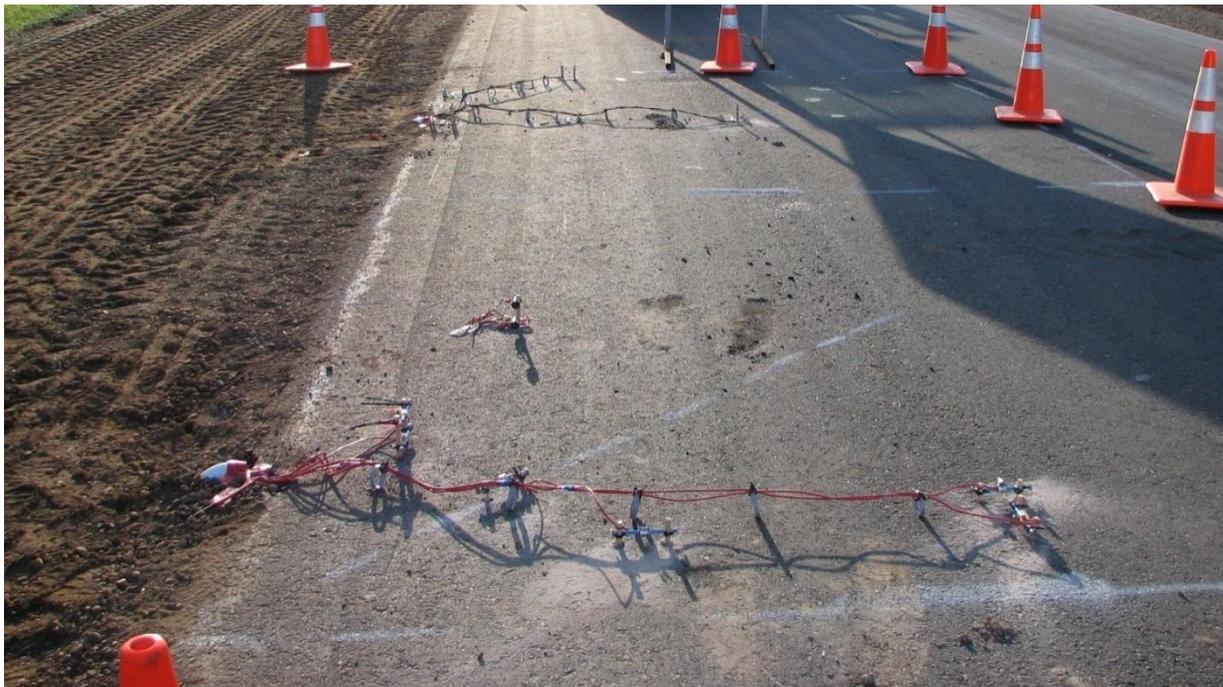
Figure 2.4. Installed Instrumentation Prior to Paving the Overlay [September 9, 2008]

Figure 2.4 shows the instrumentation configuration prior to the placement of the concrete overlay. Note the dashed white paint markings denote approximate saw cut locations that will form the transverse joints of the 12 foot long by 12 foot wide panel. This is important, as sensor placement within a concrete panel influences the measurements.

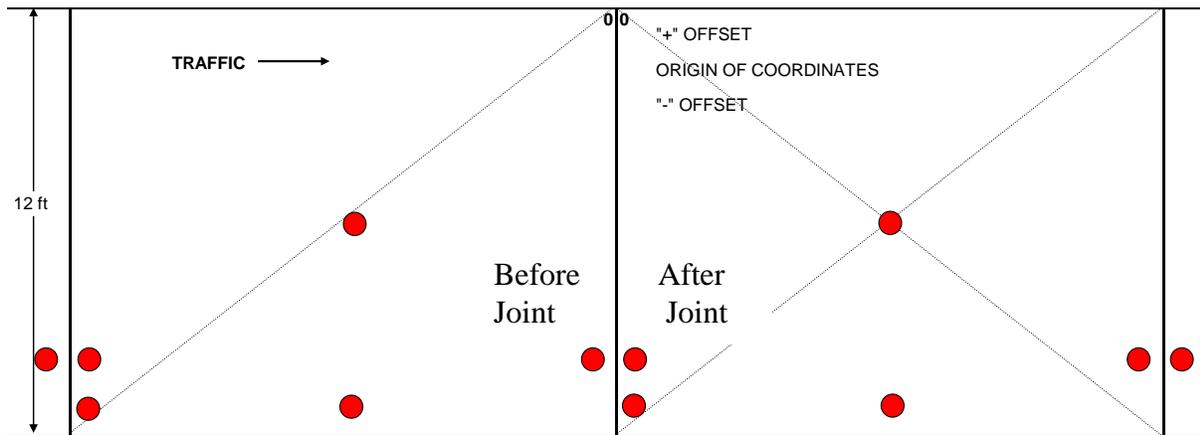
Figure 4.1. Routine FWD Testing Locations in Test Cell 53-1

The analysis included a review of the deflection results, and backcalculation. The preconstruction data showed the pavement section to be stiffer than expected and also showed the joint load transfer to be low. The post construction data also showed the pavement section as stiff as or stiffer than expected and very low differential deflection across the joints. Overall, the post construction deflection results show very good structural capacity.

FWD testing should be repeated at the same locations over the coming years to identify if structural changes occur. One possible source of change is gradual profile change of the underlying pavement due to small vertical movements caused by such things as frost heave, moisture changes, and/or long-term consolidation of the unbound material and bituminous interlayer.

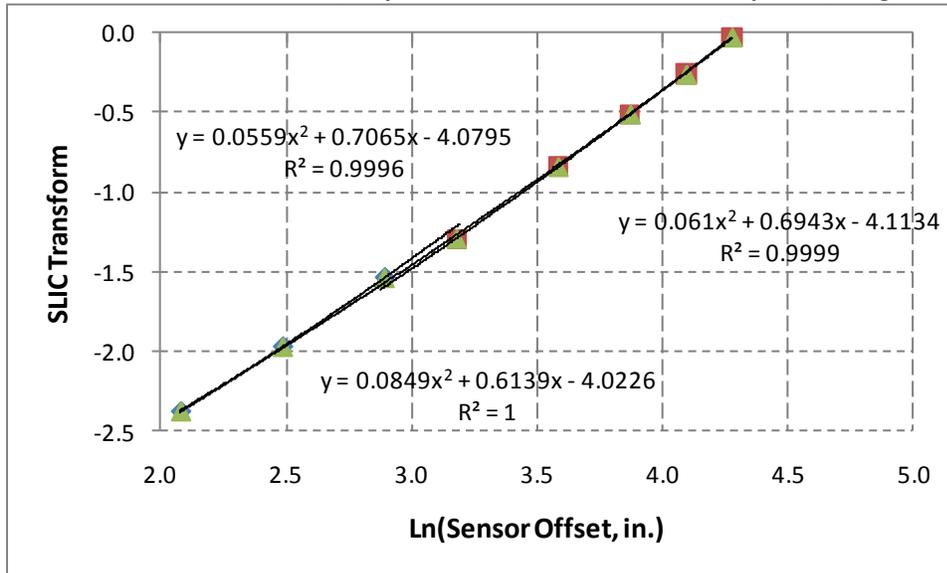
Figure 4.2. SLIC Check of Mid-Panel Deflection Data

A SLIC check was done on the mid-panel test to check for sensor function and positioning as shown in Figure 4.2. The SLIC analysis was applied to the average SLIC transformed values for all of the mid-panel deflection basins (SLIC cannot be reliably used on individual basins.) SLIC results did not find any concerns with the FWD function. It did, however, show some unique characteristics of the pavement being tested. The concave up shape of the SLIC plot indicates a very shallow deflection basin. Most highway pavements are either linear or concave down. Also, there is a slight jog in the plot line between the third and fourth

SLIC plot point indicating a slight discontinuity in the deflection basin. This discontinuity also shows up between the same sensors when comparing the measured and backcalculated deflection basins. The source of this slight discontinuity cannot be determined until SLIC results of deflections by this FWD using the same setup is evaluated. If it remains over several different pavement types, it is from the machine, but if not, it is a pavement response characteristic. The unbound concrete section (very stiff over thin soft over very stiff) might be the source.

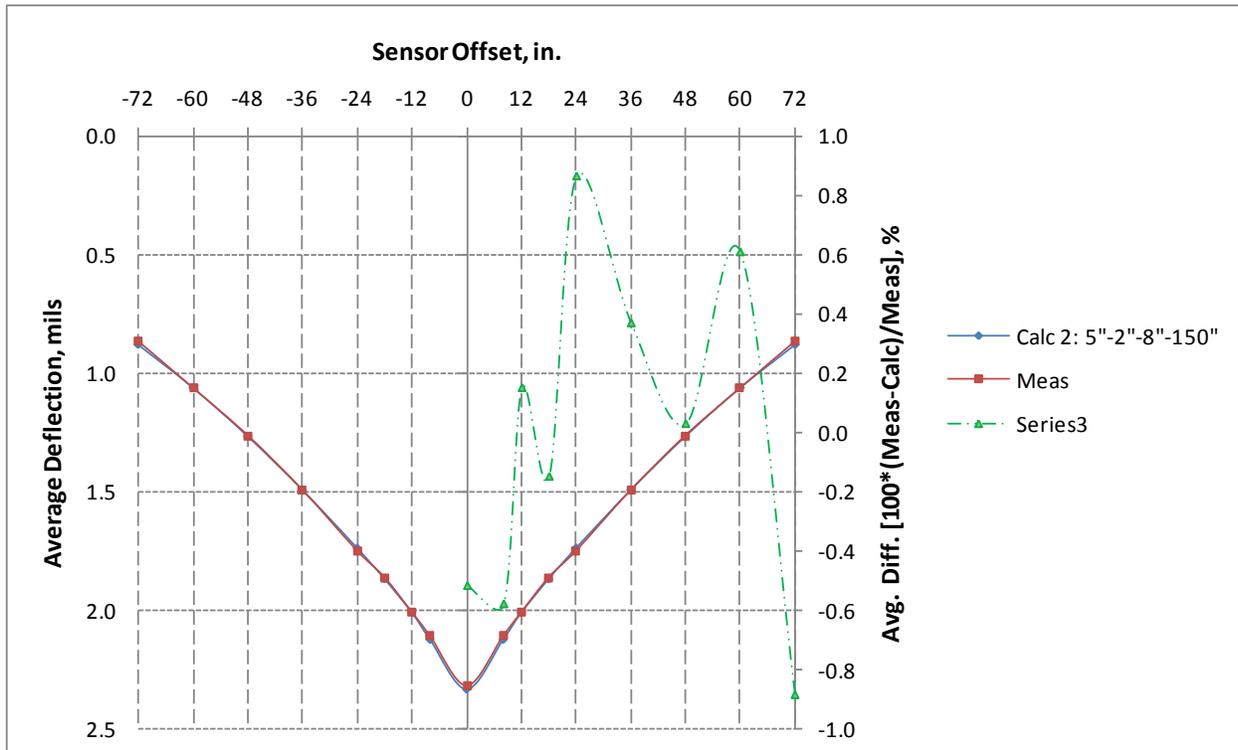
Figure 4.3. Comparison of EverCalc Calculated Deflections and the Measured Deflection

Figure 4.3 is a plot comparing the average measured and average calculated deflection basin (there are two deflection basin plots in Figure 4.3). The third wavy plot on the right side corresponds with the right secondary vertical axis and is the average percentage difference between the measured and calculated deflections, by sensor. This indicates that the average calculated deflections under the load plate are slightly higher than measured, slightly lower through the 24 to 60-inch offset, and again slightly higher at the 72-inch sensor. This high-low-high pattern, if strong enough could be an indication that the model (layering or thicknesses) might need to be adjusted. In this case, however, the absolute magnitude of the differences are so low that they are all less than the precision capability of the FWD (about plus or minus 0.9 percent plus or minus 2 microns). It would make no sense to adjust the model to try to improve on the fit because there are likely many small adjustments that could be made that would result in improvement, but no rational way of identifying the one that is most representative of the pavement tested.

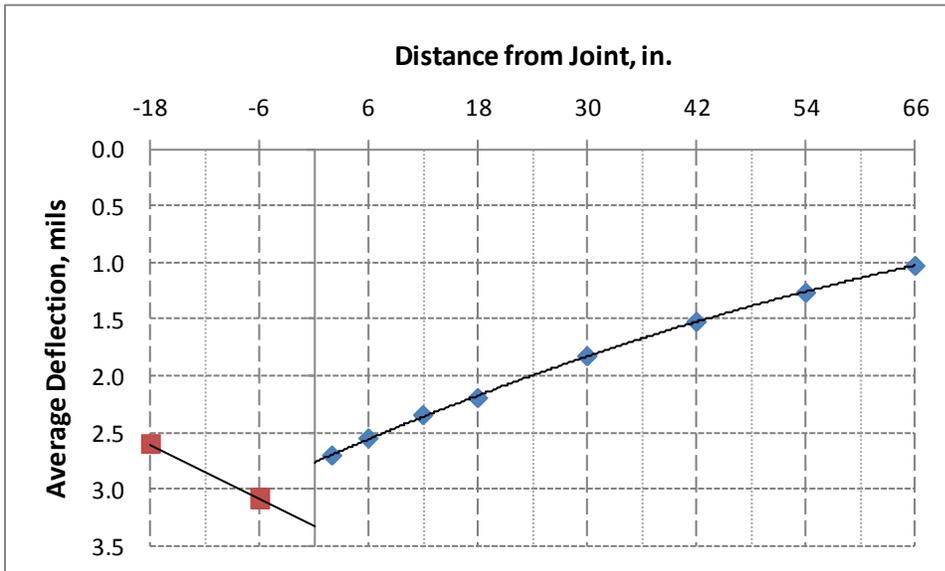
Figure 4.4. Average Deflection Basin when the Load Plate is Before the Joint

The traditional method used to evaluate the load transfer efficiency of the joint is to use the deflection sensor that is about the same distance away from the joint on the unloaded side as distance the sensor at the center of the load plate is from the joint. With the FWD configuration used August 21, 2009, the sensor 12 inches in front of the load plate is divided by the deflection under the load plate when the plate is before the joint. When the plate is in front of the joint, the deflection 12 inches behind the load plate is divided by the deflection under the load plate. The results are expressed as a percentage. Typical values for new conventional doweled concrete pavements are in the low to mid 90 percent range. The average load transfer efficiency (LTE) for this pavement at the time of test is 84 percent. The average difference in deflection across the joint however is very low at 0.56 mils. The difference in the intercepts of the surface deflection plots shown in Figure 4.4 is 0.76 mils. This can be inferred to be representative of the actual differential slab movement at the joint during a transient 9,000 lb impulse load.

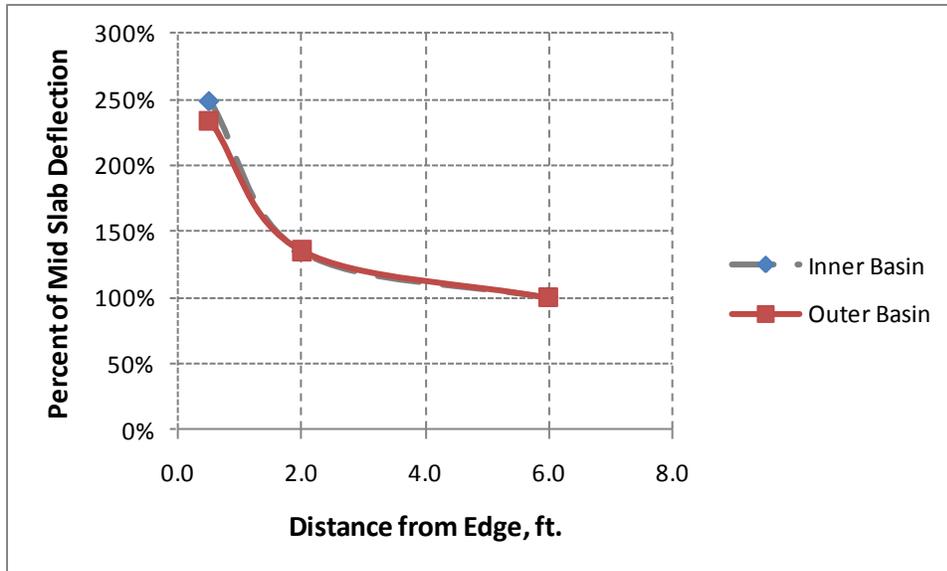
Figure 4.6. Comparison of the Deflections by Distance from Center of Slab

The mid-panel deflections tend to be lower than the deflections at the edges of the slab. The two plots in Figure 4.6 show the deflections increase as the load moves from the center of the slab toward the edge. The ‘Inner Basin’ plot comparison is for the sensors 0 to 24 inches from the center of the load and the ‘Outer Basin’ plot compares the deflections from the sensors 36 to 72 inches from the center of the slab. Both the inner and outer part of the basin increase about the same amount with the inner part increasing slightly more than the outer part. This infers that much of the increase is due to the combined effect of being closer to the edge and less support under the edge of the slab.

The critical loading locations for conventional concrete pavements are at the corners and edges. This unbonded pavements also had the highest deflections at the corners and edges, but the deflections are lower. The average corner deflections under the load plate are about 2.75 times greater than that measured at the center of the slabs. There were a couple center lane joint tests and the deflections there were similar to that measured at the center of the slab. The deflection difference between the center of the load plate was actually smaller than measured mid-slab, possibly due to higher slab temperatures at the surface during mid-day August testing.
